**Implementing Agreement for  
a Programme of Research and  
Development on Wind Energy  
Conversion Systems – Annex XI**

**22<sup>th</sup> Meeting of Experts –  
Effects of Environment on  
Wind Turbine Safety and Performance**

**Wilhelmshaven, June 16, 1992**

## **Danish Experience with Environmental Extremes on Wind Turbine Application**

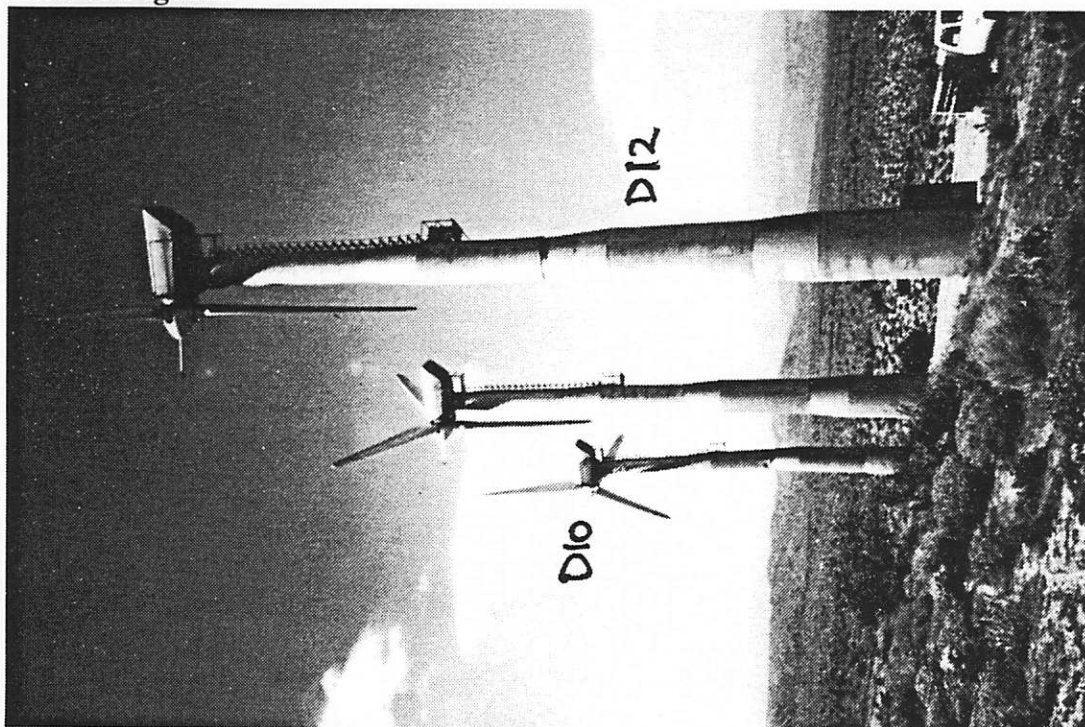
In the wind turbine area of California a earthquake initiated vibrations and damages on 66 Bonus 65 kW wind turbines on july 8, 1986 <sup>1/</sup>. During the quake of strength 5.9 on the Richter scale with epicenter 18 km N of Palm Springs the wind turbines were spinning in a 16 m/s wind. Local effects at Painted Hill site intensified the shaking to a equivalent of 6.9 on the Richter scale. However, a inspection report <sup>1/</sup> concluded that 16 wind turbines did show no visible damages and that 50 units were damaged, of them 25 severe. 7 wind turbines towers were taken off-line: they suffered buckling on the tower and cracks at the inspection door and the concrete base. The bucking zone was limited to the section just above the concentric part of the circular tower at the root of the third tower part, which is 50 % of the tower height. Photos of the wecs are shown in the paper. Minor damaged parts were repaired after inspection.

1 Earthquake impact on wind turbines D10 and D12.

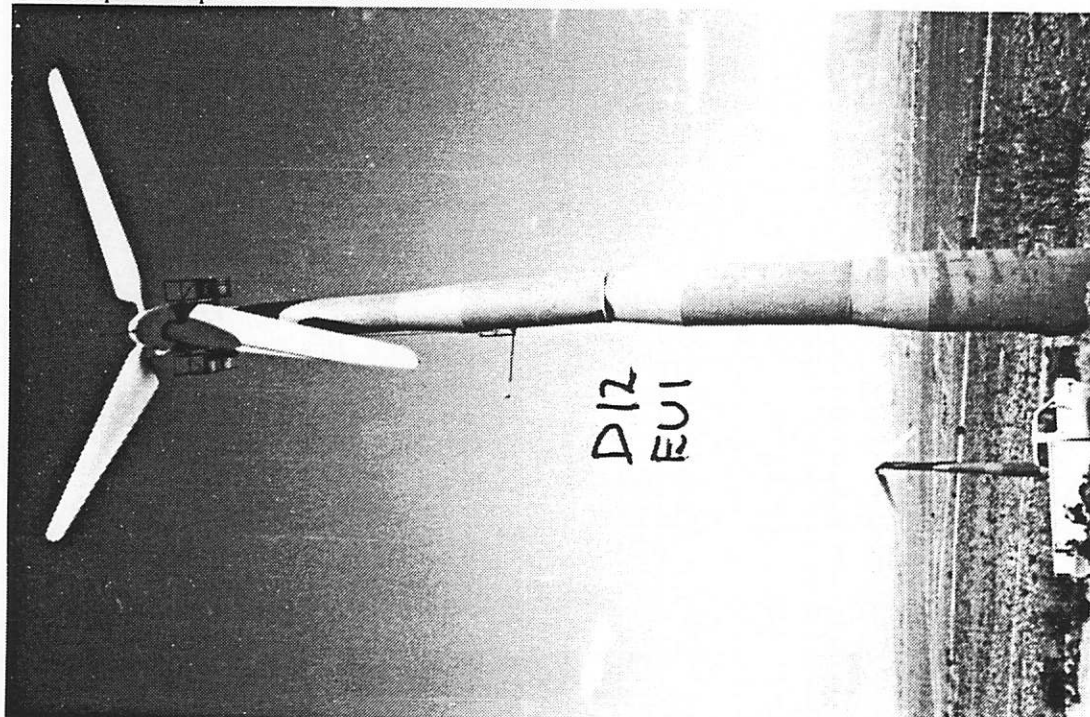
2 Earthquake impact on wind turbines D10 and D12.

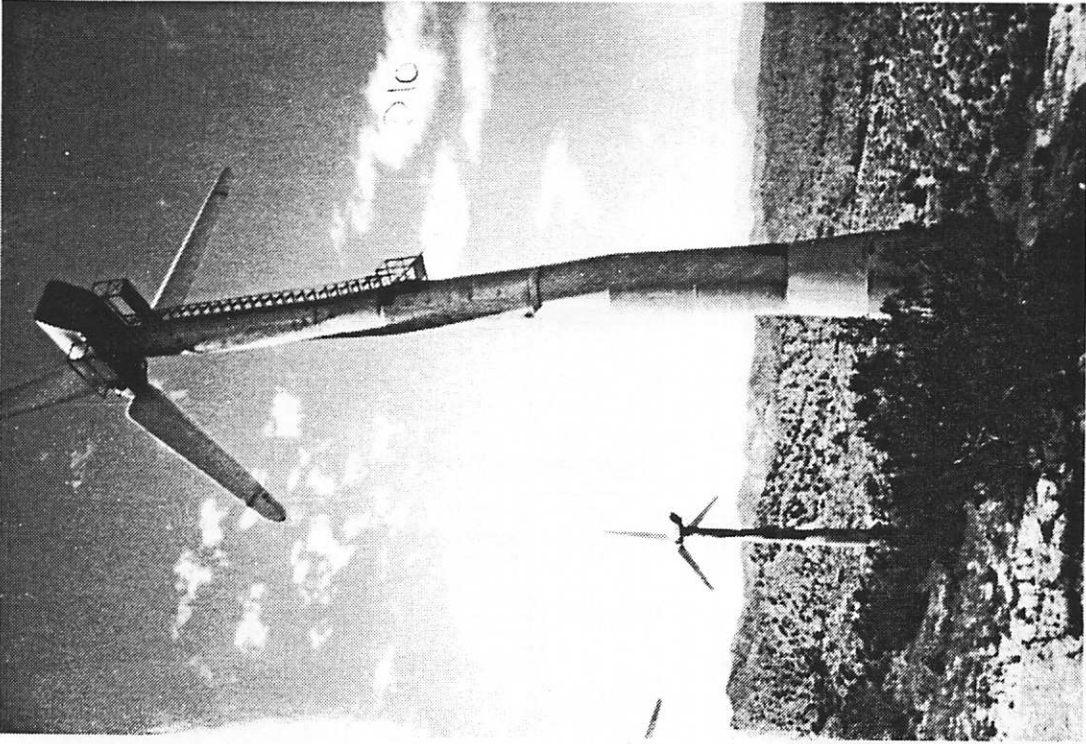
3 Earthquake impact on wind turbines D10 and D12.

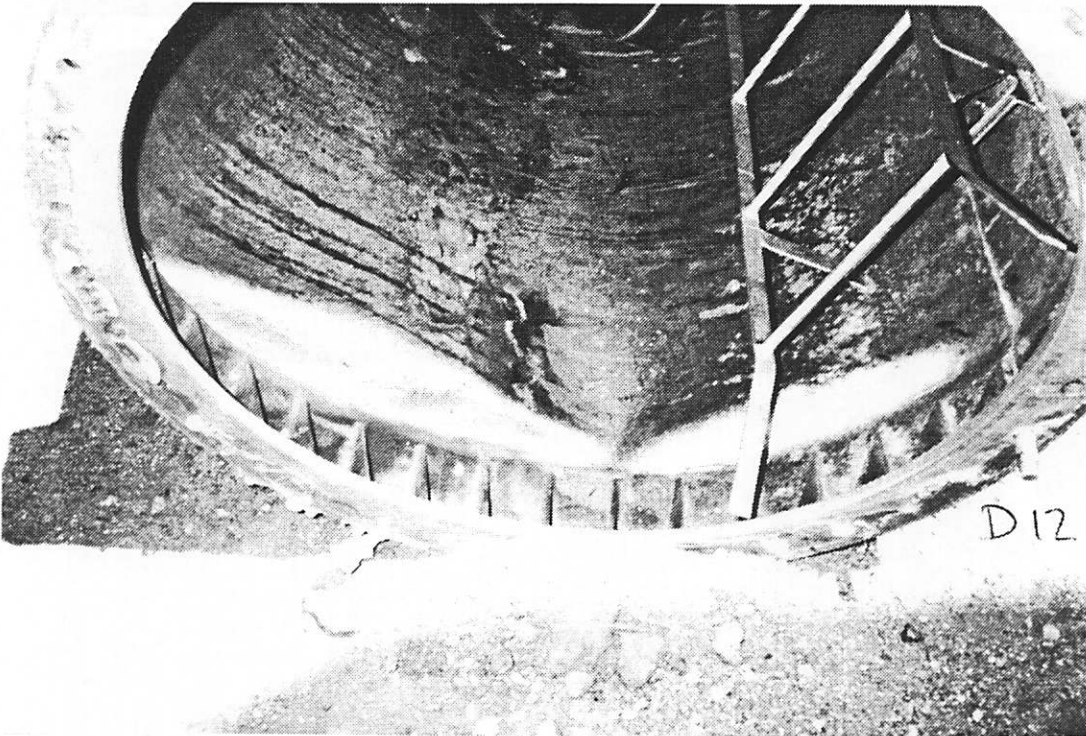
4 Buckling zone of wind turbines D12.

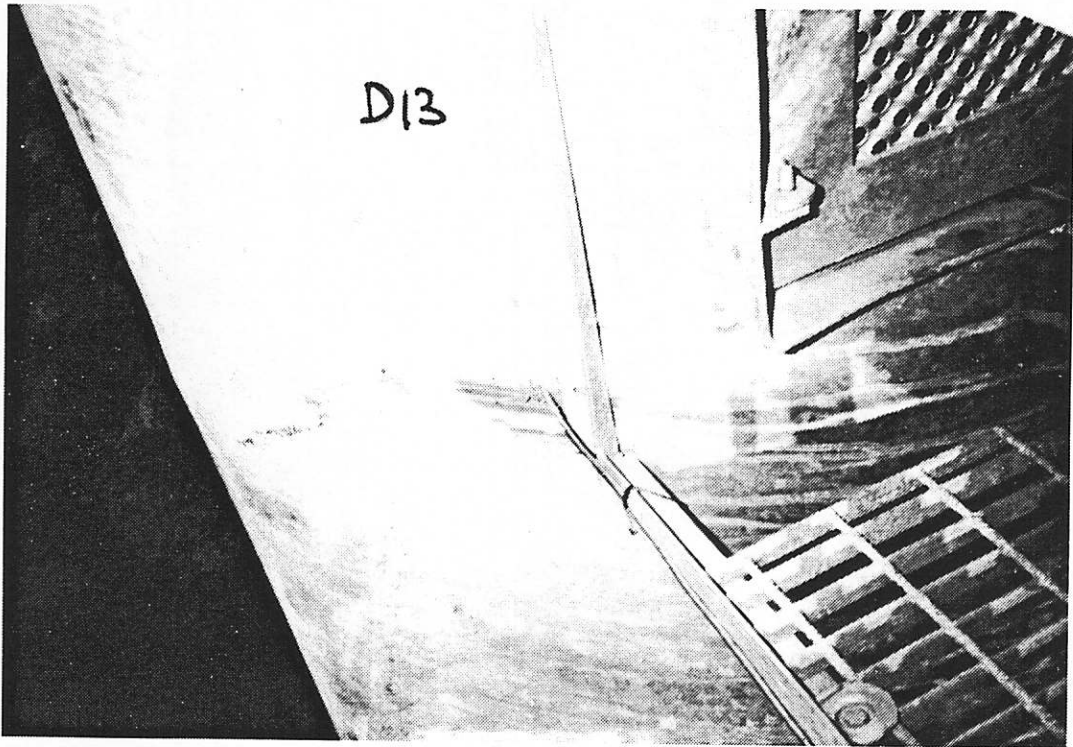
5 Cracks at the inspection door of wind turbine D13.

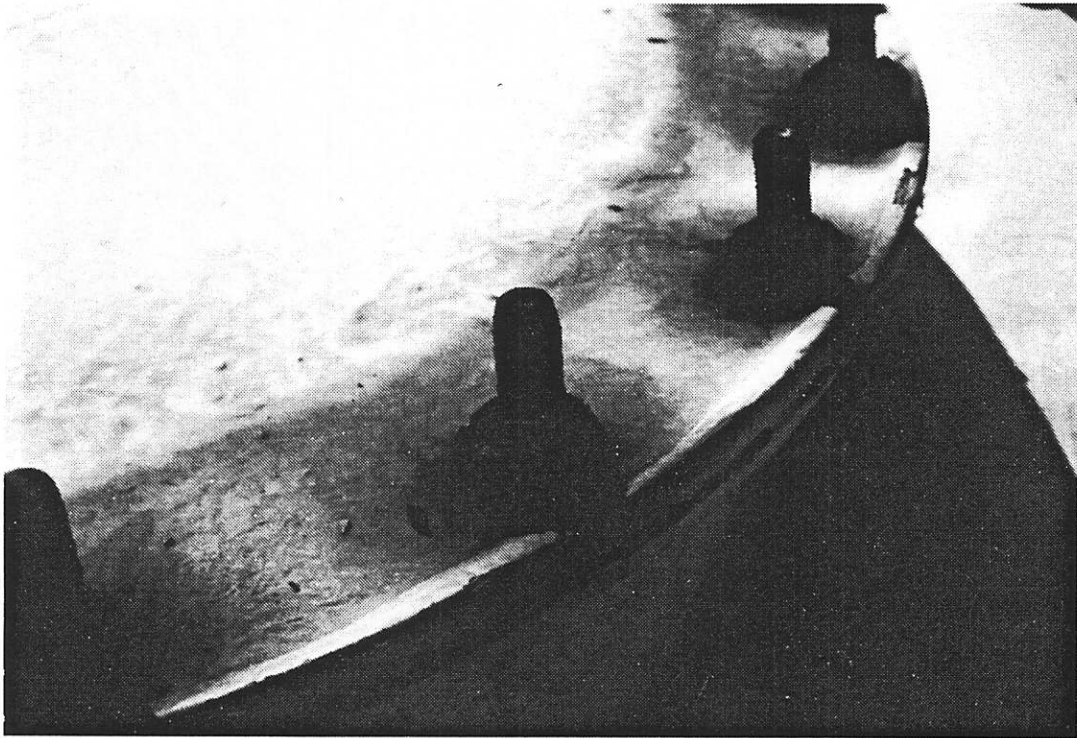
pct. The site conditions for the four 55 kW Bonus wind turbine units were extremely aggressive due to the strong corrosion from the airborne salt particles of the nearby sea. The corrosion rate is demonstrated with a photo of different stainless and galvanized bolts of different quality, exposed to the open air for a period of one year before installation of the wind turbines. The experiment showed that only a bolt of type A4 according to the Swedish standards resisted the corrosive environment. In view of the climate of the site supplemental anti-corrosion treatment according to danish standards DS/454&DS/464 was initiated at the wind turbine factory. The electronic equipment was moisture protected, the hot dip galvanized towers were additionally epoxy painted and the generators were protected against tropical environment. After installation and after some time of operation, the precautions initially taken showed shortcomings: Severe corrosion were detected on the blade root flange bolts(see Fig.). They were not replaced by the more resistant bolt type A4 at the time of construction. The painting layer of the tower was insufficient thick to resist the injection of condensed water, resulting in a oxidation process with spots as shown in the photos. Authorities like the Danish Corrosion Center advised sets of instructions for the overhaul and maintenance of the steel parts. Some instructions involved highly skilled labor for application of the two-component epoxy painting. The company decided to fix the rotor blades with acid resistant flange bolts and to perform a preparation- and painting program, advised by the corrosion specialists. The Mogadishu experience learned that more rigorous precautions against corrosion, listed as non-mandatory guidelines in the appendix should be employed for wind turbines in extreme environment at the time of production.

7 Test sample of different stainless steel bolts/Somalia.

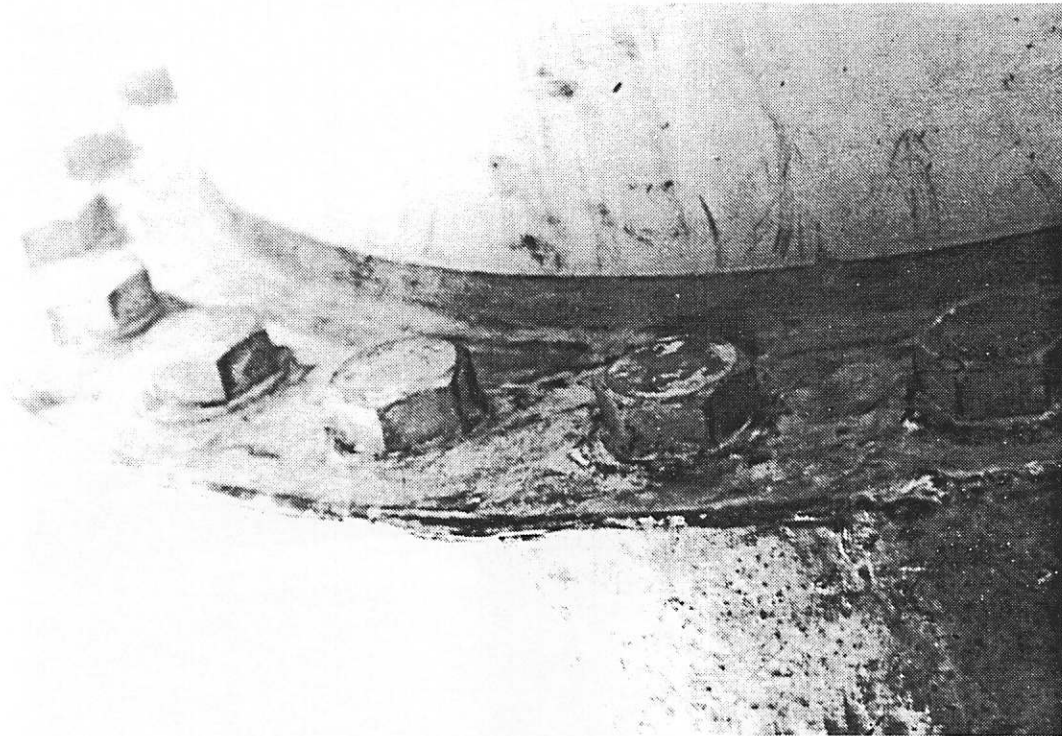
8 Flange bolts on wind turbine blade/Somalia.

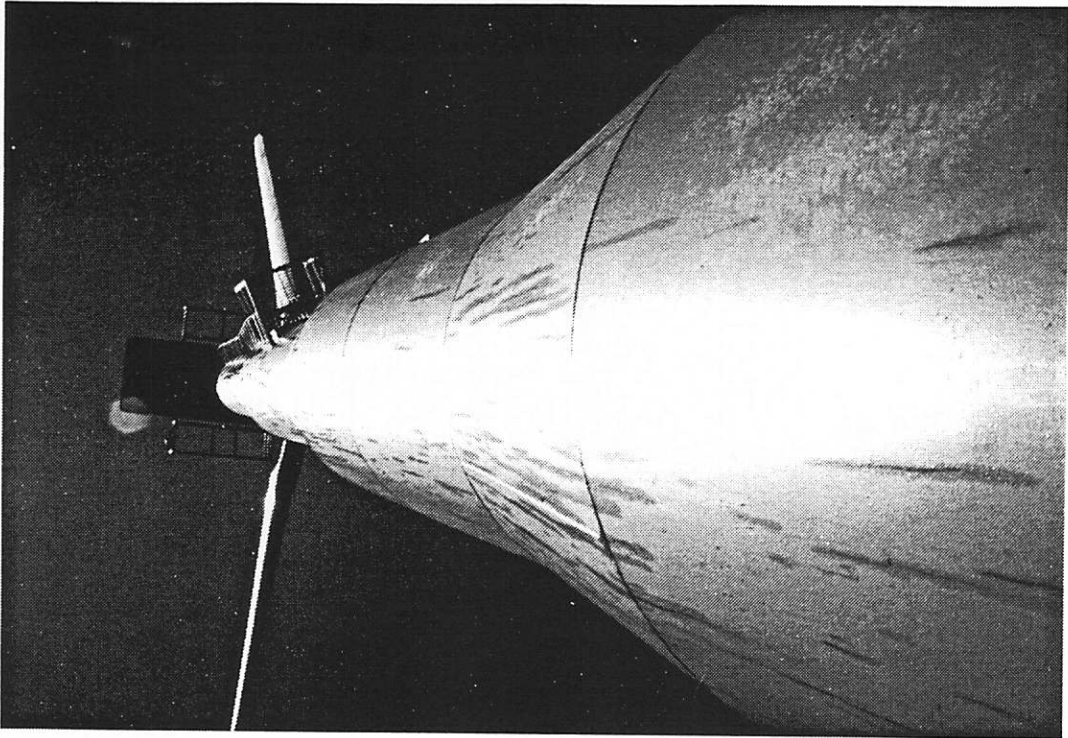
9 Wet spots on the leeward tower side/Somalia.

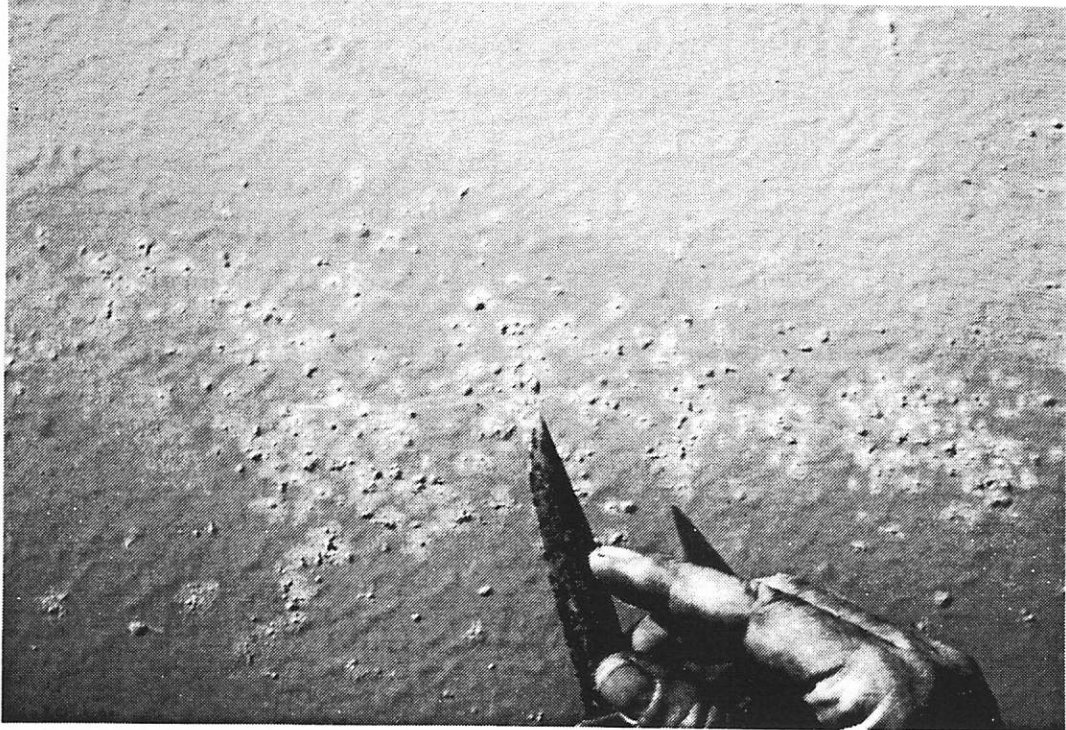
10 Oxide spots on the tower surface/Somalia.

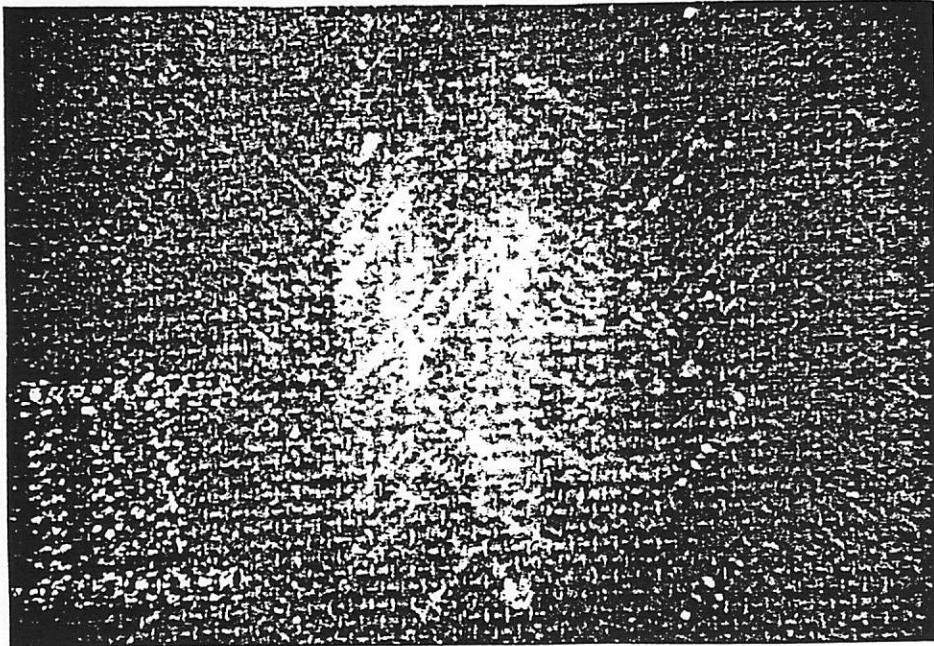
Fig. 2: Crack Pattern on Backside of Impacted GI- Ep Specimen

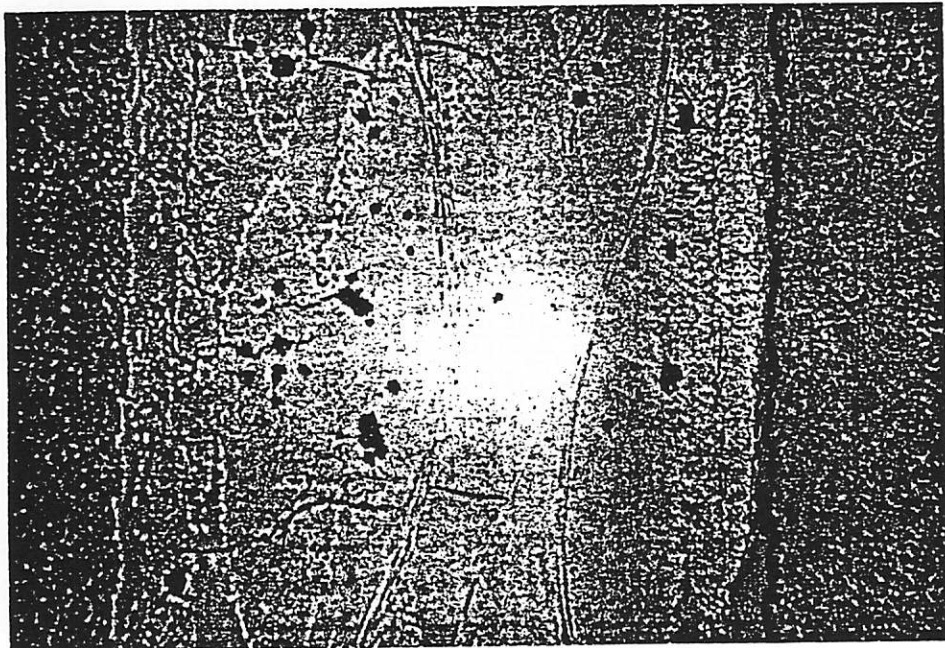
Fig. 3: Crack Pattern in Cross Section of Specimen
