Implementing Agreement for Co-operation in the
Research and Development of Wind Turbine Systems
ANNEX XI

26th Meeting of Experts

Lightning Protection of Wind Turbine Generator Systems and EMC Problems in the Associated Control Systems

Cologno Monzese, March 8 - 9, 1994

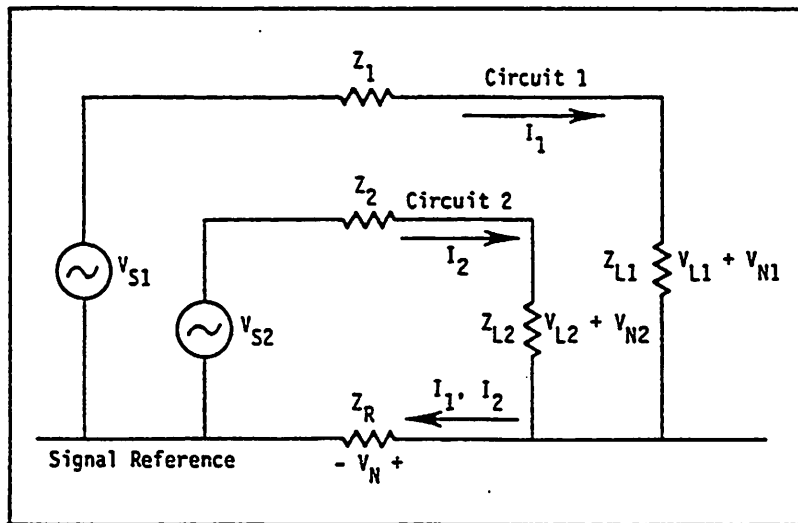
Coupling Between Circuits Caused by Common Return Path Impedance.

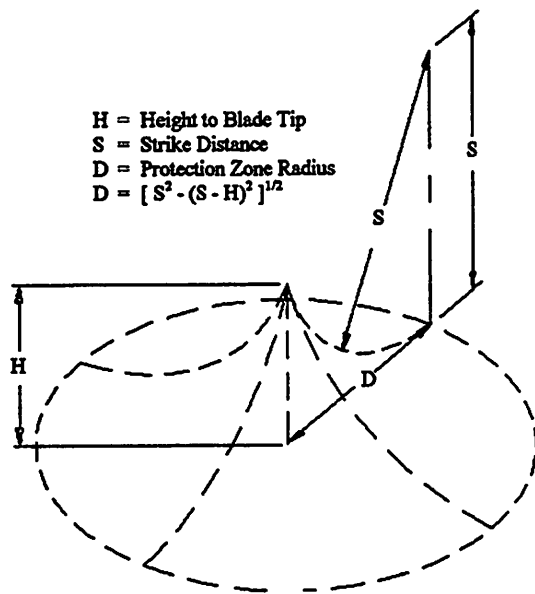
Figure 1. Rolling Sphere Zone of Protection

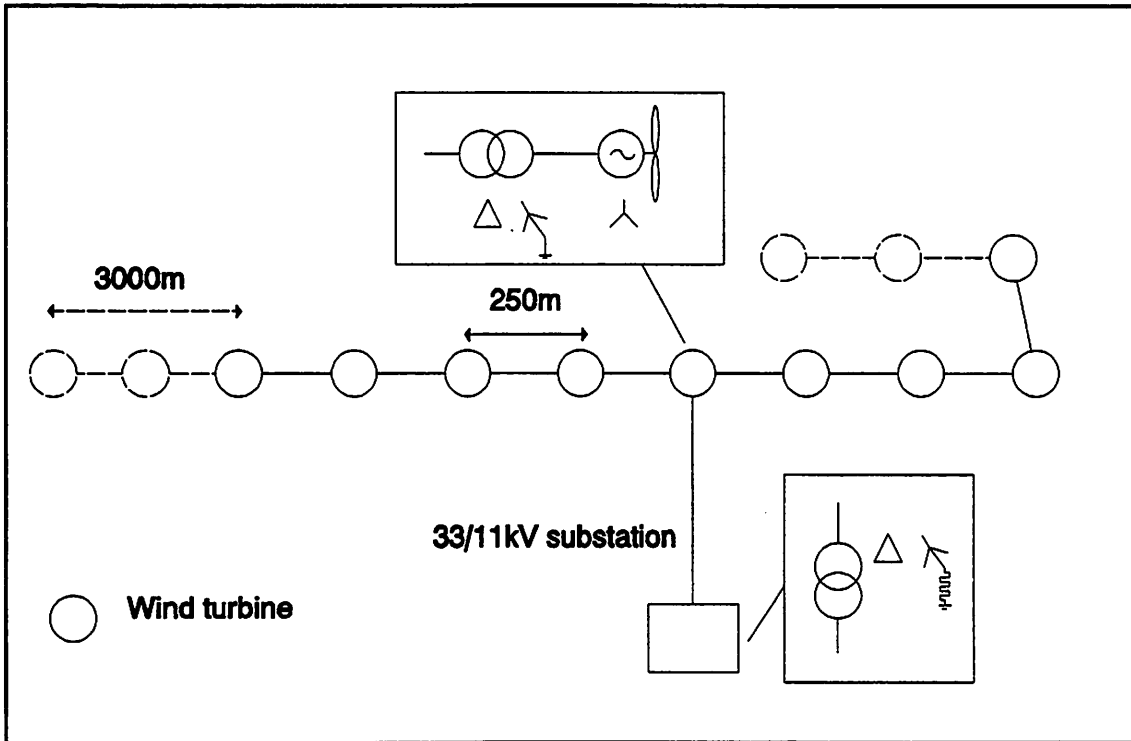
Figure 1 Electrical schematic of wind farm
