Task 46 Erosion of Wind Turbine Blades Work Package #5 Erosion Mechanics and material properties

WP5 IEA Task46. Public webinar 4th December 2023

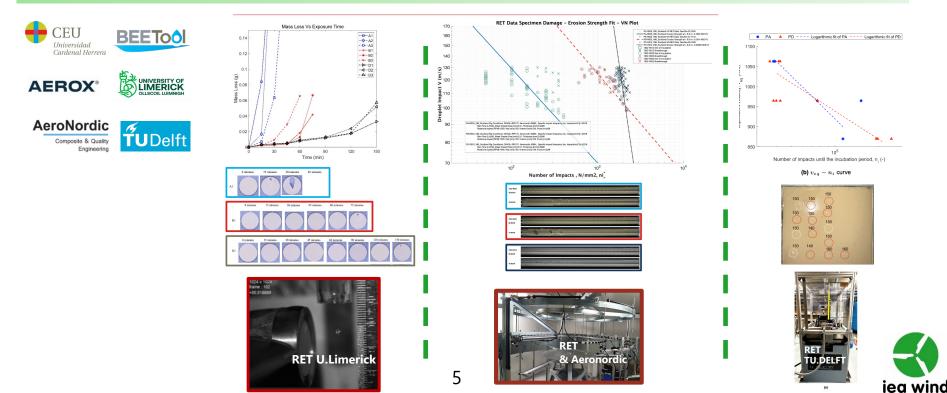
- ✓ **FINISHED: UV Degradation combined weathering and RET; Different chemistry comparison**
- ✓ FINISHED: Damage progression analysis based on 1) images V-N curves, 2) intermediate mass loss and
 - ON GOING: 3) damage progression based on intermediate geometry loss

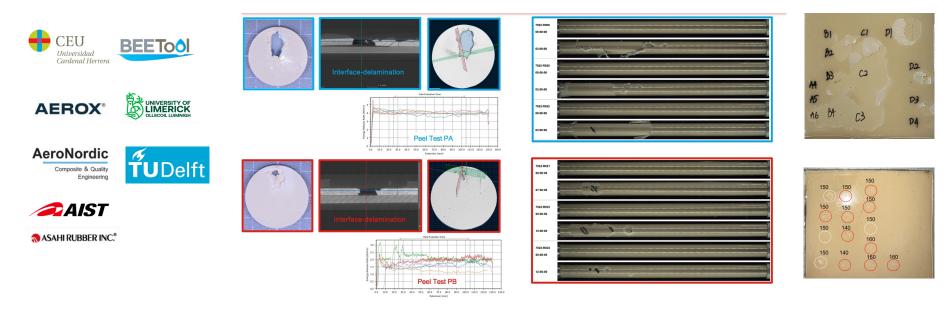
- ✓ FINISHED: RET , MicroCT and Peeling –tests for initial case developments.
- ON GOING: To extend RET related with interfaced damage
- ON GOING: Further RET and material analysis and appropriate analysis for **Manufacturing issues** due to **LEP configuration**, application procedure, LEP **blade integration** technology.
