Task 46, Erosion of Wind Turbine Blades

5th International Symposium on Leading Edge Erosion of Wind Turbine Blades, DTU, 6-8 February 2024

IEA Wind TCP Task 46

Erosion of Wind Turbine Blades

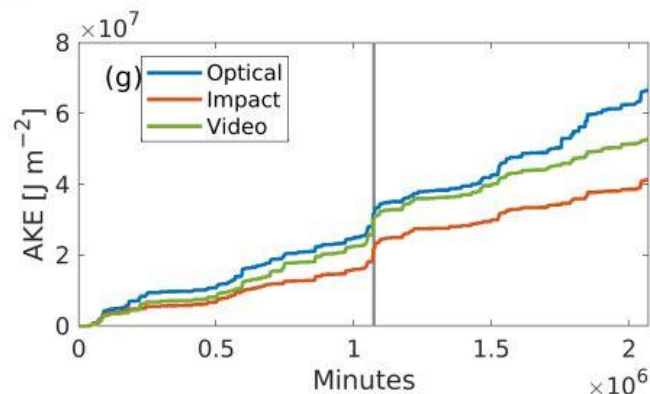
- Example of influence of measurement technology on 'LEE estimates'
 - AKE = Accumulated Kinetic Energy of impact
 - ADF = Accumulated Distance to Failure (from Springer).

- That the instrumentation used to measure rainfall rates, and hydrometeor size & phase CRITICALLY dictate the inferred rate of LEE (e.g. estimated by Springer model).
- That there is NOT best practice available for data collection OR processing
- That commonly used size distributions for hydrometeors DO NOT represent observations

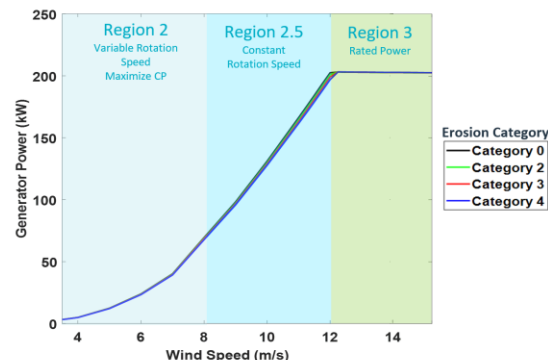
Aerodynamic Performance

Power loss is defined in Region 2 of the power curve.

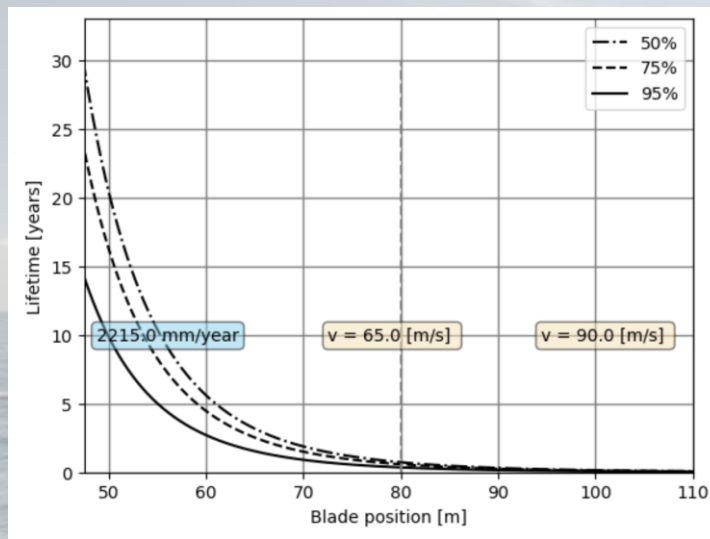
- Python-Jupityr notebook implementation of DNV-GL 0573
 - Improved regression analysis
 - High Impact on predicted lifetimes
 - N-dependent
