IEA Wind Task 46
Erosion of wind turbine blades

**Leading Edge Erosion Classification
System**

Technical report

December 2022

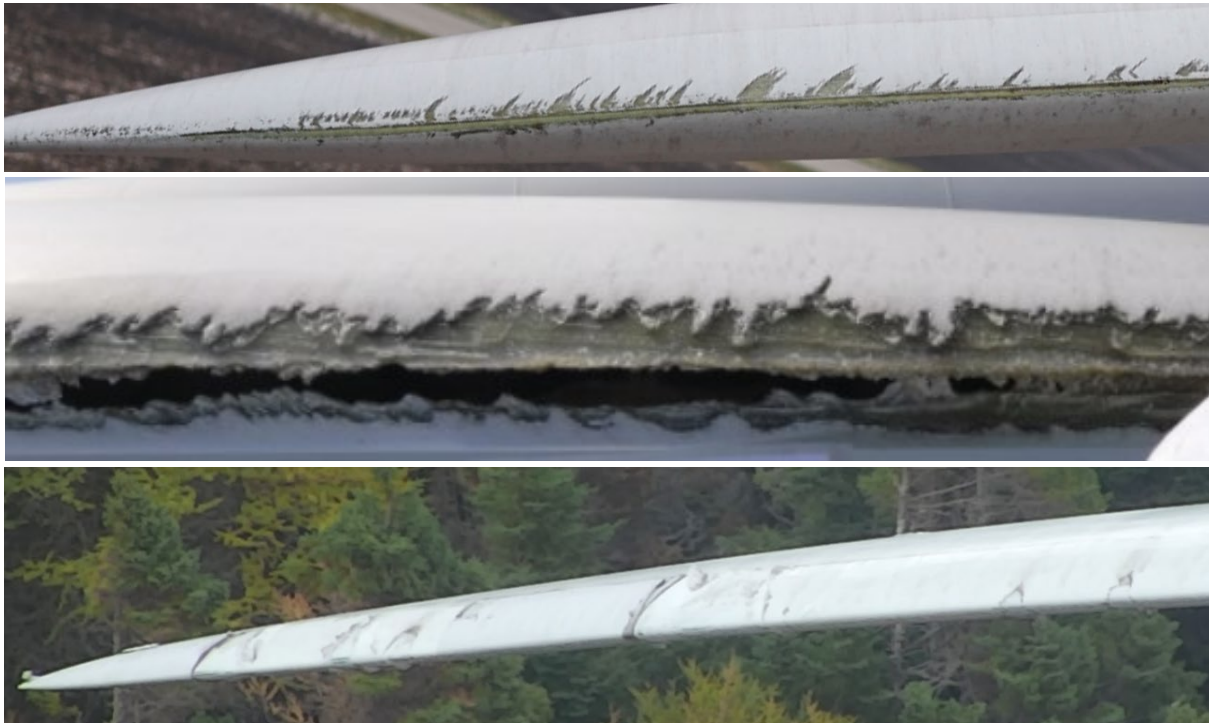
Figure 2-1 – Examples of wind turbine blade erosion damage (top - progression of leading edge erosion, middle – untreated leading edge erosion resulting in open cavity, bottom – damage to leading edge protection tape).

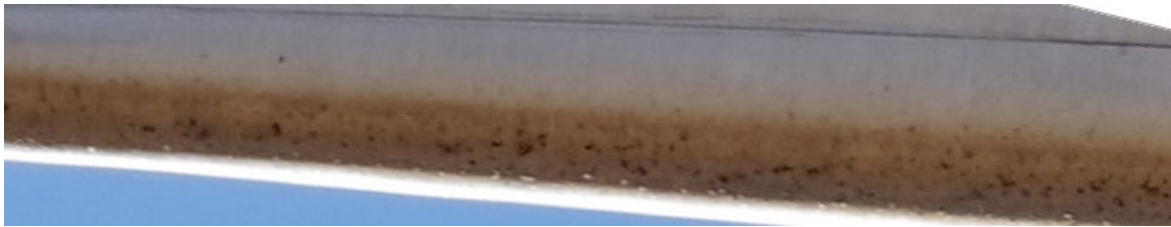
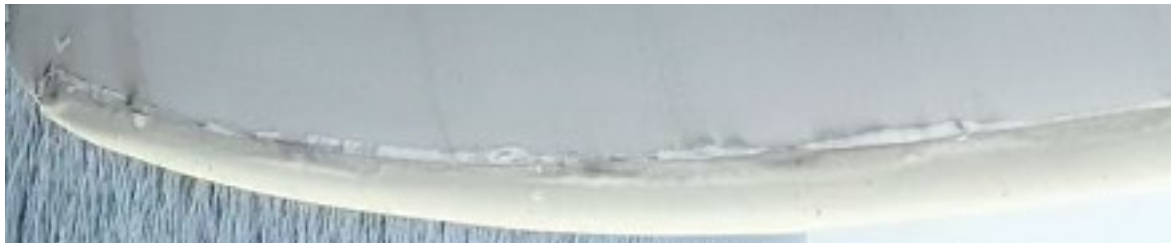
Damage threshold: individual instances $\geq 1\text{cm}^2$ & individual instances $\leq 10\text{cm}^2$

- The expectation is that the LEP is still intact and providing protection to the underlying layers.
- However, the incubation period of the LEP has ended and there are noticeable instances of localized damage on the LEP that are greater than 1cm^2 but less than 10cm^2 in area.
- Discernable peeling/reduced adhesion noted on edges of leading edge protection.

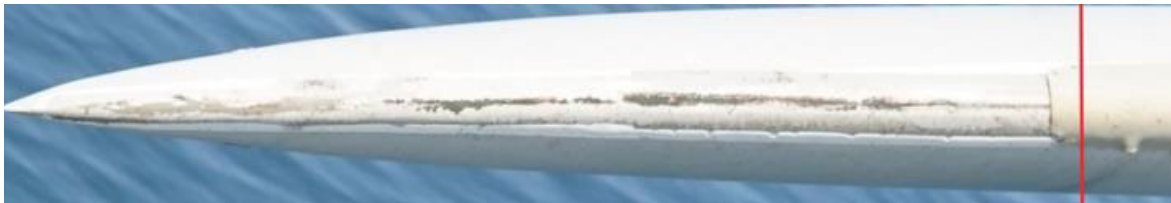
Damage threshold: destruction of LEP $\geq 1\text{m}^2$

- Destruction of the LEP is obvious over a considerable length of the leading edge.
- Adhesion failure has resulted in a considerable length of the leading edge being unprotected.

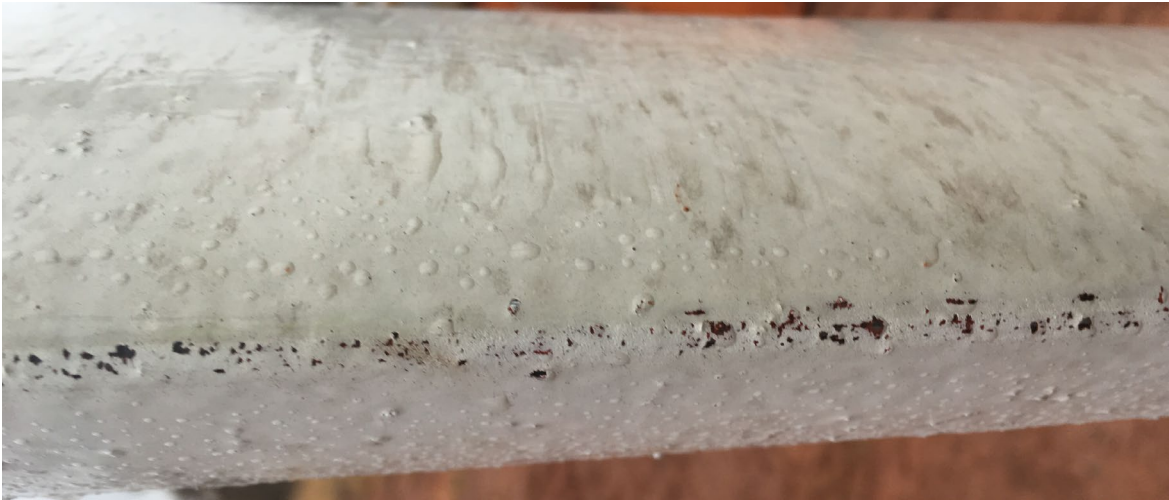
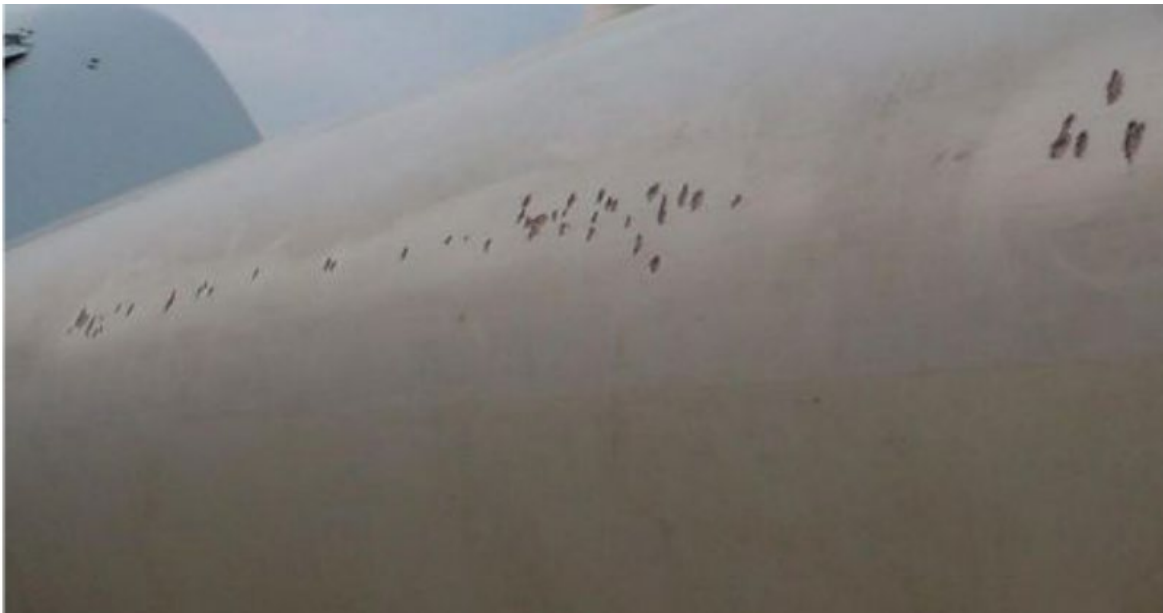
Level 2 (No LEP) – “Localized Pitting”

Damage threshold: individual instances $\geq 1\text{cm}^2$

- Multiple individual pits are noted

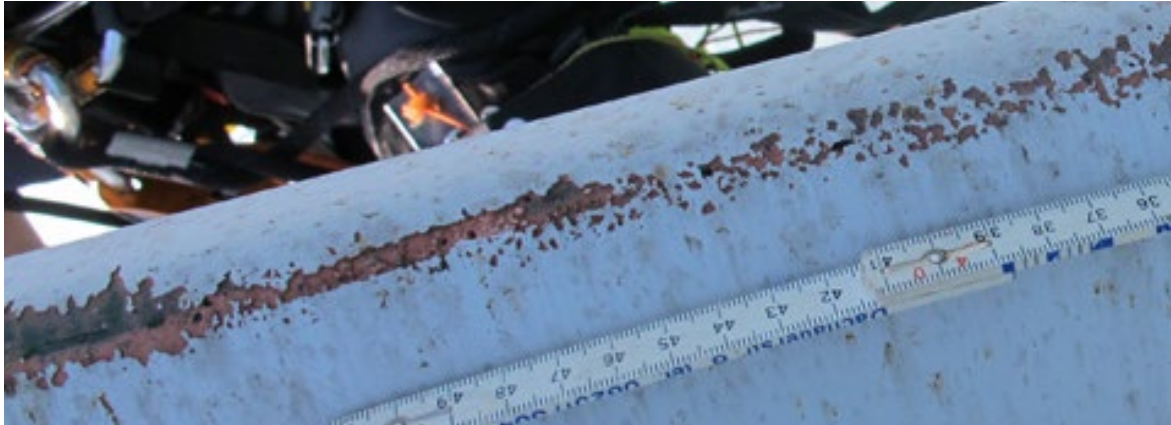
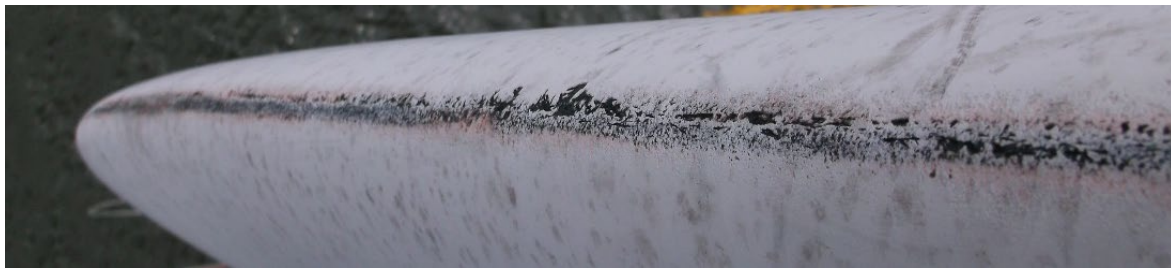
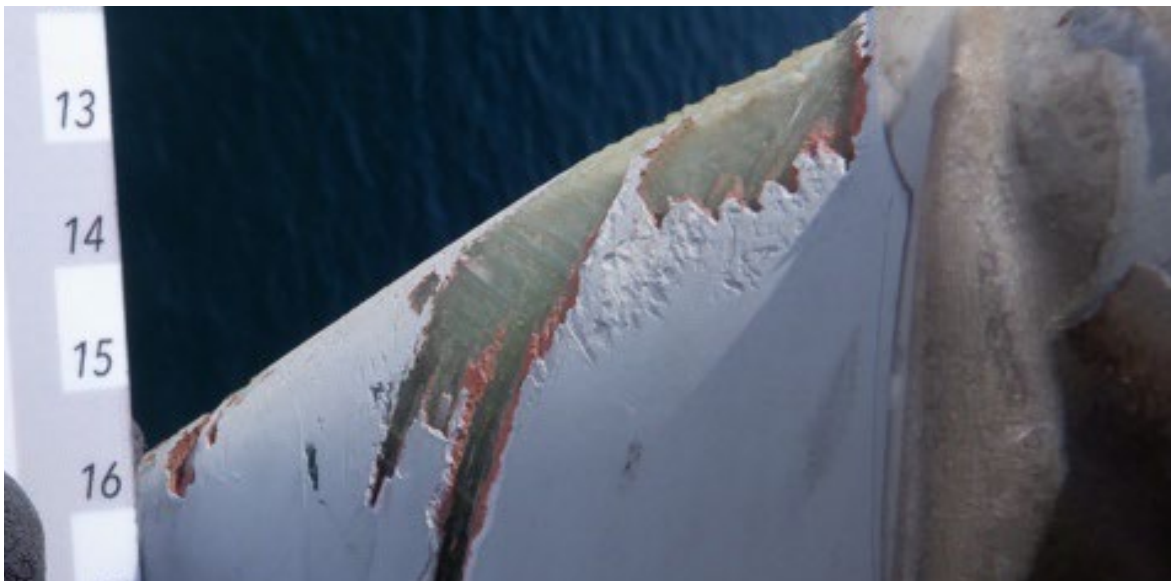
Level 3 (No LEP) – “Widespread or coherent pits, some gouges”

Damage threshold: erosion of topcoat $\leq 10\text{cm}^2$

- Pits are widespread and cohesive over a significant continuous length of the blade.
- Underlying composite layers may be clearly visible but not over a large overall area.

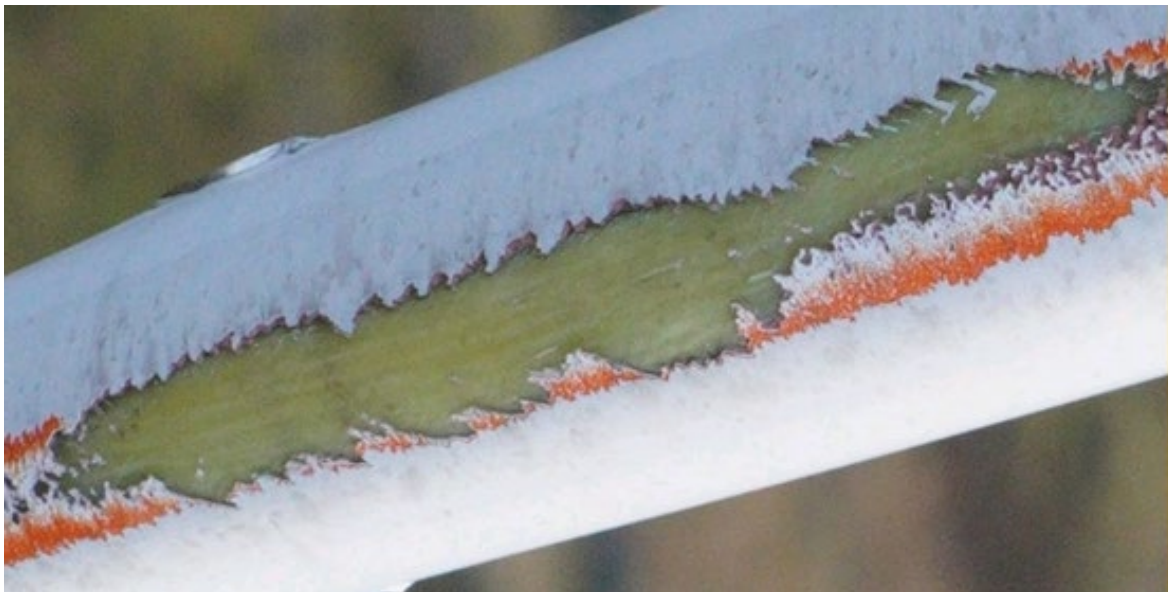
Level 4 – “Erosion of topcoat with immediate layer underneath visible and exposed”

Damage threshold: erosion of topcoat $\geq 10\text{cm}^2$; erosion of laminate $\leq 1\text{cm}^2$

- Erosion has worn away to the laminate such that the filler layer or immediate laminate is observable over an area greater than 10cm^2
- Damage to the substrate is either not entirely obvious or sufficiently small/minor.

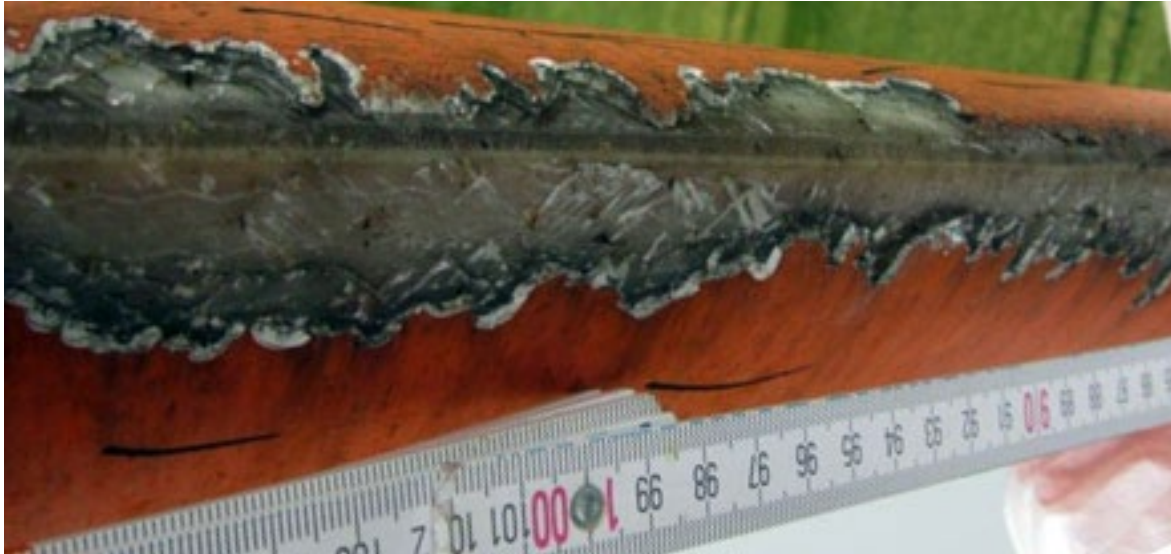
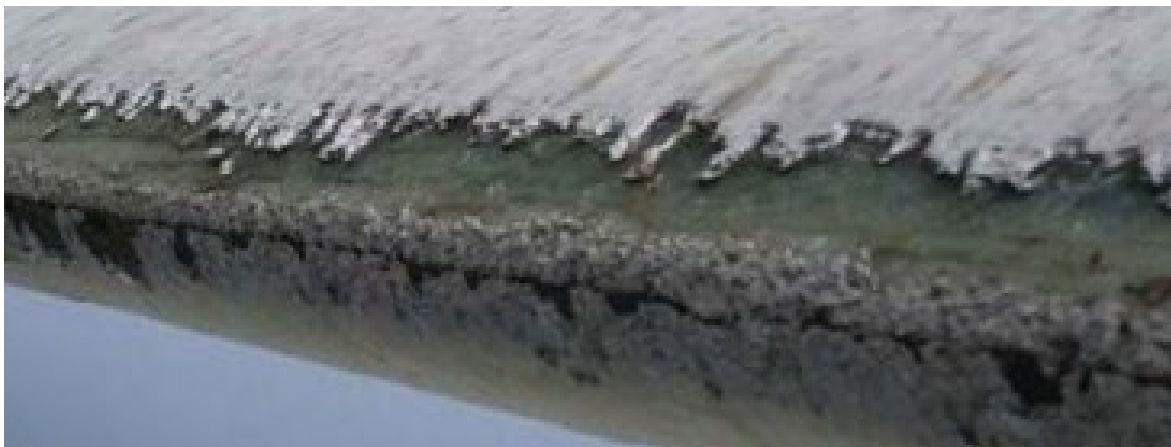
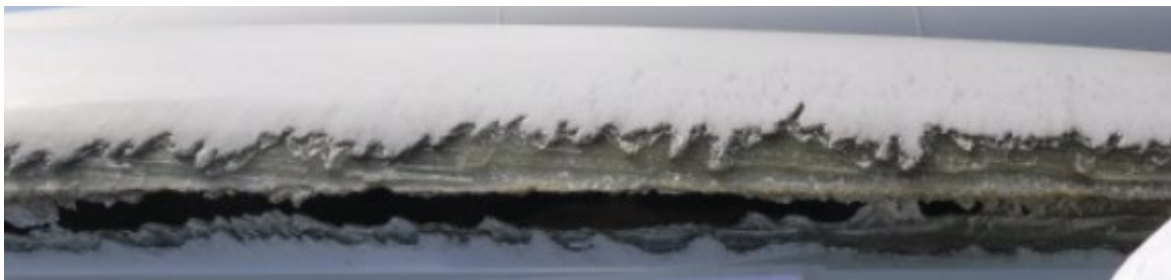
Level 5 – “Notable damage to substrate”

Damage threshold: erosion of laminate $\geq 1\text{cm}^2$

- Obvious damage to the laminate layers.
- Any damage beyond the threshold will still be classed as Level 5.

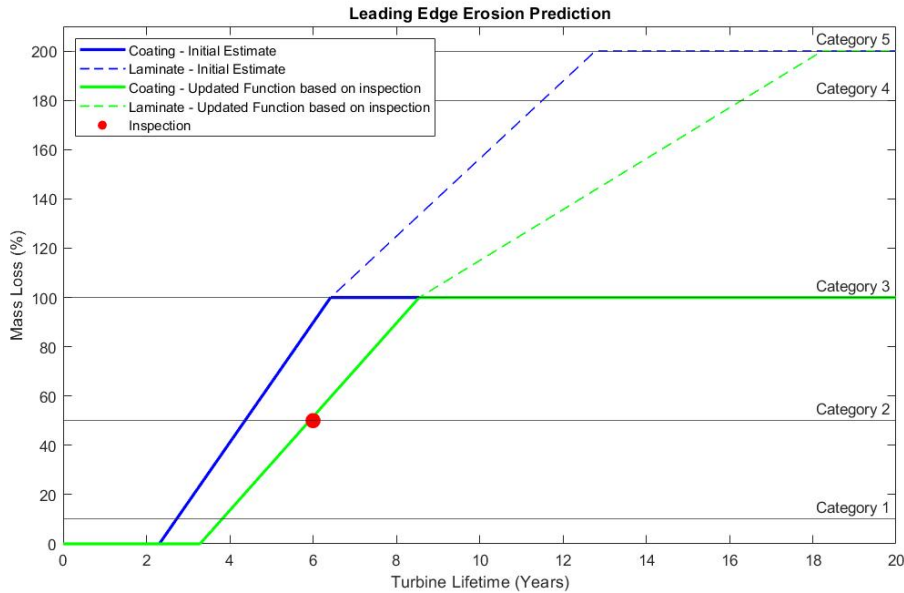
Figure 4-1 – Example plot of leading-edge erosion prediction of a wind blade airfoil section where initial model estimates are updated to better fit inspection data from the field.

One approach is to use percent eroded area of an airfoil leading edge section as a proxy for percent mass loss at that blade section e.g., if 20% of the leading-edge topcoat area is eroded away, that would correspond to a 20% mass loss of the topcoat. After leading edge erosion is detected and categorized on a blade, a function involving a combination of the Springer model weighted by rain and wind statistics can be curve fit to the inspection data, see figure below (Verma, et al., 2021) Additionally, Eisenberg observed that erosion damage is proportional to the local incoming blade velocity ($\propto V^{6.7}$); if blade radius is used as an analog for velocity than this relationship along with inspection data and the probability weighted Springer model can be used to determine either the rate of erosion loss along the entire blade and/or incubation time if erosion has not started to occur in certain areas (Eisenberg, et al., 2018). The incubation time and mass loss rate are a function of the blade laminate and the environmental conditions. Assuming that the environmental conditions in the past are relatively similar to those in the future, an estimate can be made of the future erosion state. This estimate can be further refined with subsequent inspections and the

uncertainty of the model can also be reduced with better measurements of either the actual mass loss, the blade construction, and the real environmental conditions. A prototypical definition of the relationship between mass loss and erosion class was given in Table 5. The model assumes different mass loss rates for coated and uncoated composites after the erosion progresses through the coated. This model is currently under development and will need to be validated against wind plant inspection and operational data, a process that is currently underway.

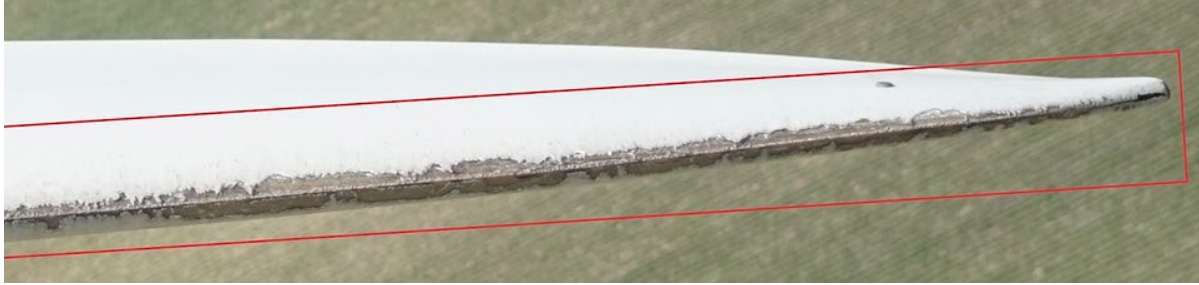
Parameter (Specified by Service Provider)	Value
Material	Laminate
Blade Length	37 m
Distance from Root	37.3 m
Length of damage	4.1 m
Width of damage	0.15 m

Criteria	Severity Level	Note
Visual Condition	4	Large, exposed surfaces of fiberglass. Signs of damage to the underlying fiberglass
Mass-loss or Depth	4	
Aerodynamics/Performance	4	
Structural	3

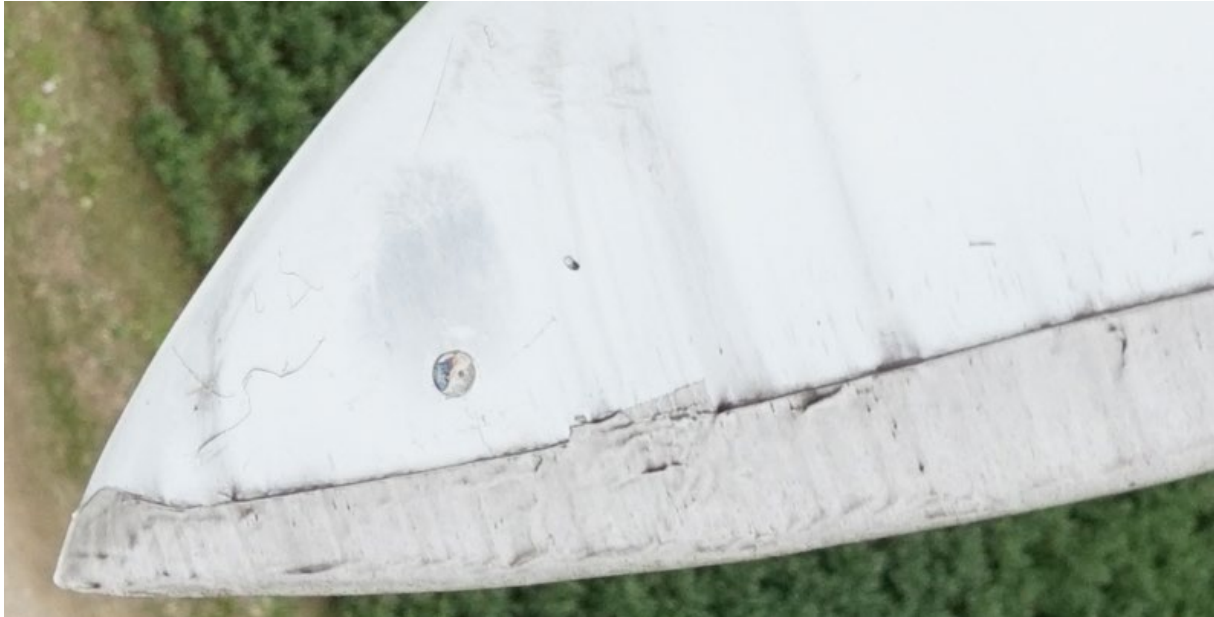
Parameter (Specified by Service Provider)	Value
Material	PU Coating
LEP Width (Total PS & SS)	200 mm
Blade Length	49 m

Criteria	Severity Level	Note
Visual Condition	2	Tape is in poor condition but attached.
Mass-loss or Depth	1	
Aerodynamics/Performance	2	Tape is in poor condition, cat. 2-3 perf. loss
Structural	1

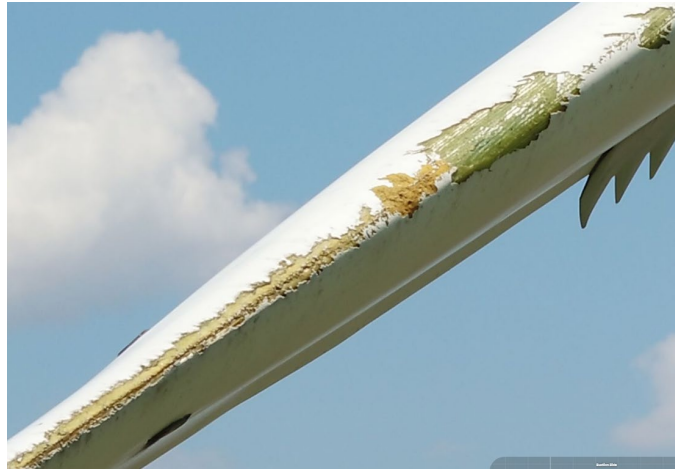
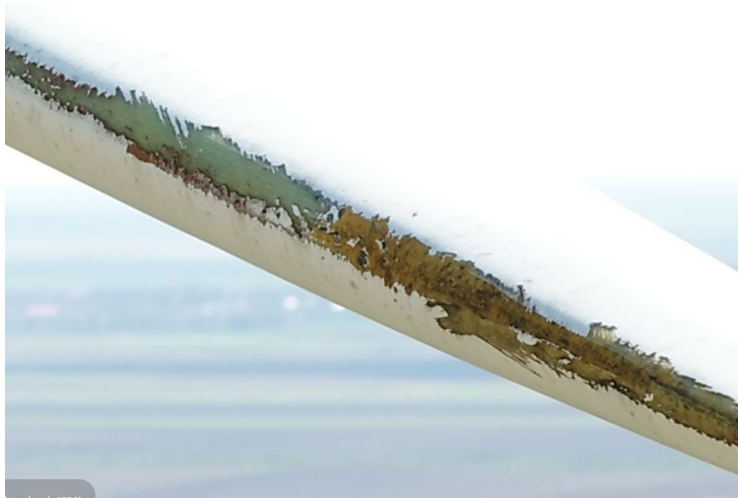
The above three images are examples of category 4 erosion via visual identification. The outer layers of coating and material are completely removed along the leading edge and the underlying layers of material are now eroding. The aerodynamic loss of these areas of the blade likely falls into standard category 4 as well.

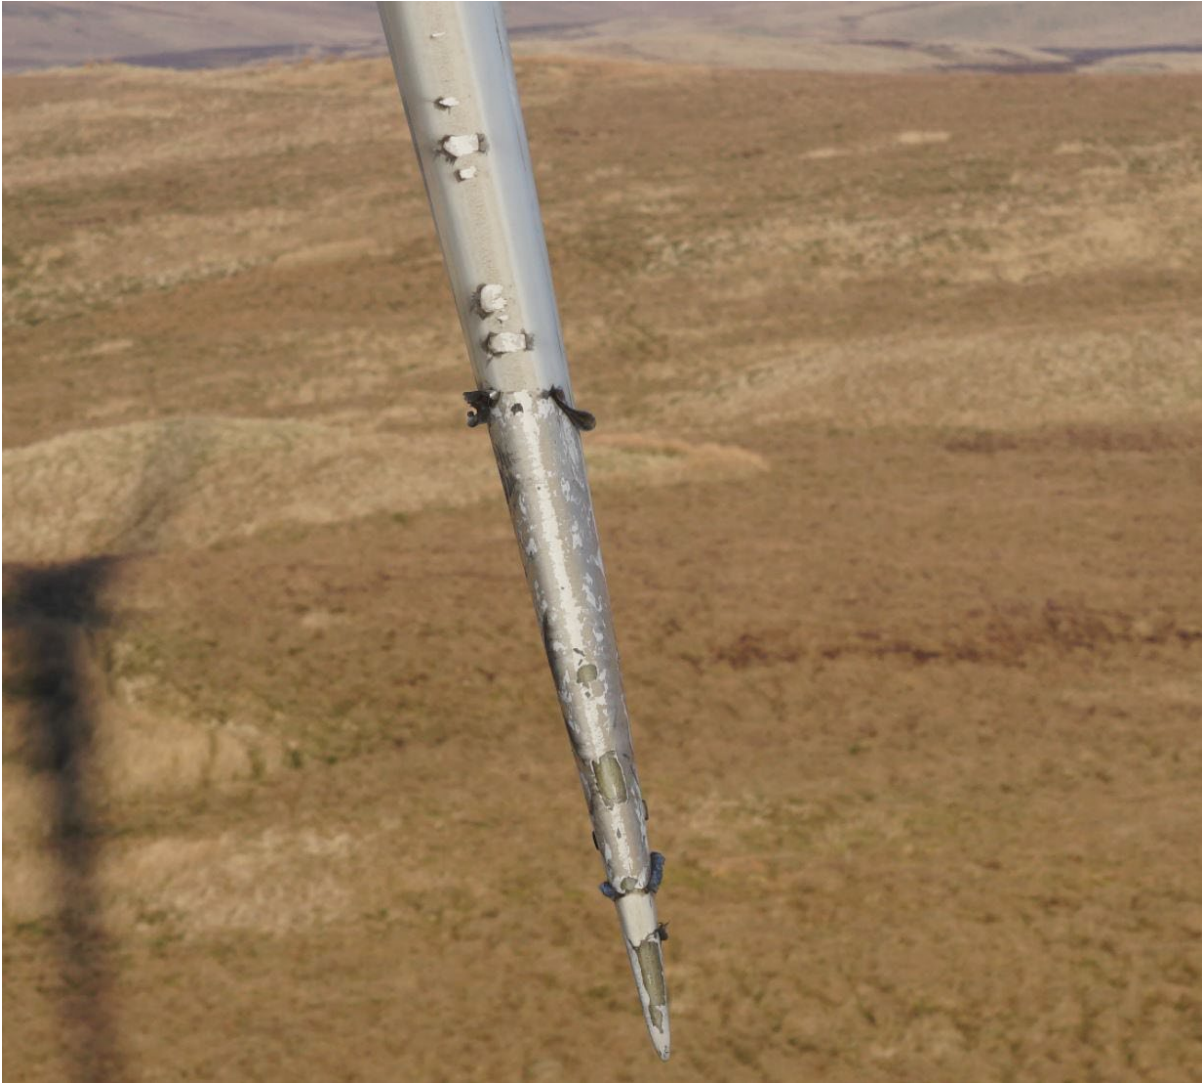
This blade shows leading edge protection delamination and peeling. The underlying blade does not appear to yet have severe erosion, category 1 with some category 2 areas; however, the areas of peeled leading edge protection material could cause aerodynamic flow transition and possibly separation over local areas, increasing the drag to equivalent of a higher blade erosion category, likely category 3 and possible even category 4 in some local areas.

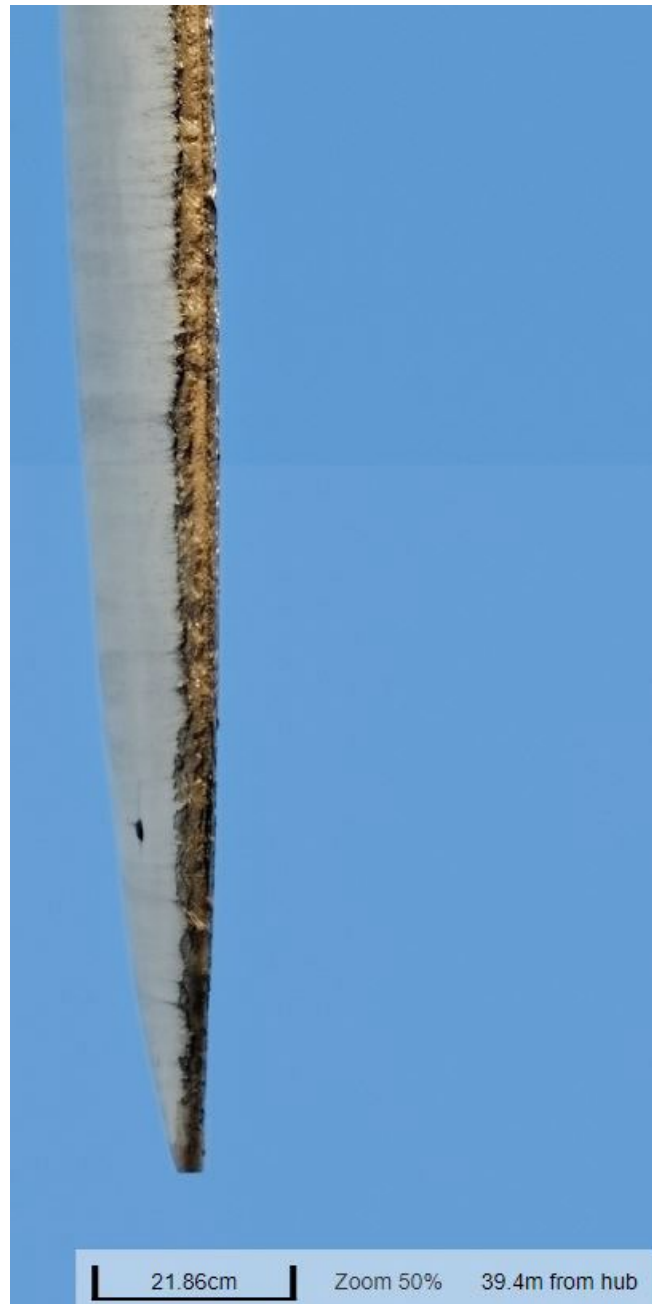
This blade has experienced severe erosion. It is at the high end of category 4, with the underlying structural material exposed and eroding, and will move to category 5 if it hasn't already in local areas.

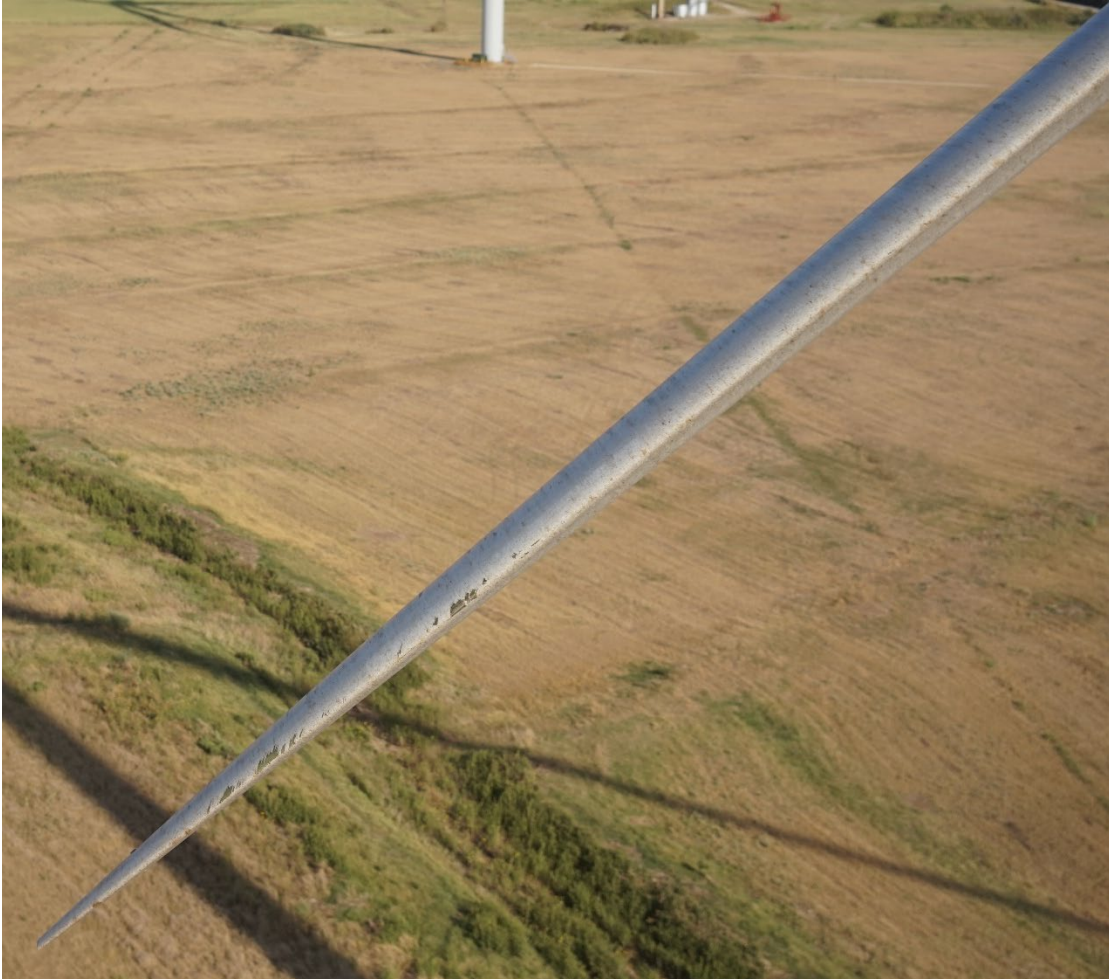
This blade shows lighter erosion and no leading edge protection. The blade would fall into category 2 due to local pitting and some areas of deeper erosion and delamination.

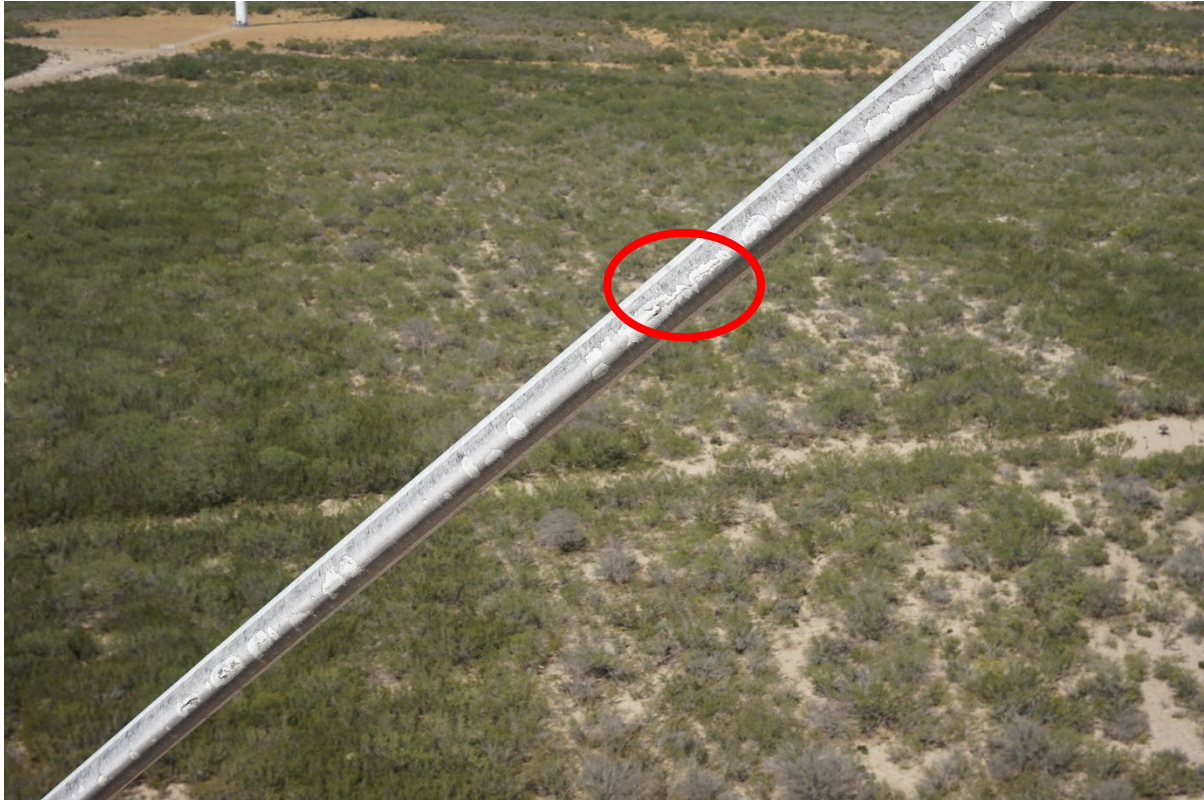
This image shows failing leading edge protection. The leading edge protection is rated category 3, as it is no longer providing protection on large areas of the blade. The underlying blade surface appears to have category 2 erosion in some small pockets where the protection has failed. This example shows the difficulty in local categorization versus categorizing the entire blade. It also shows the challenging nature of assessment with limited visual data, as the severity of the damage above the middle of the image (circled) is not clear and could be a structural crack or simply surface damage.

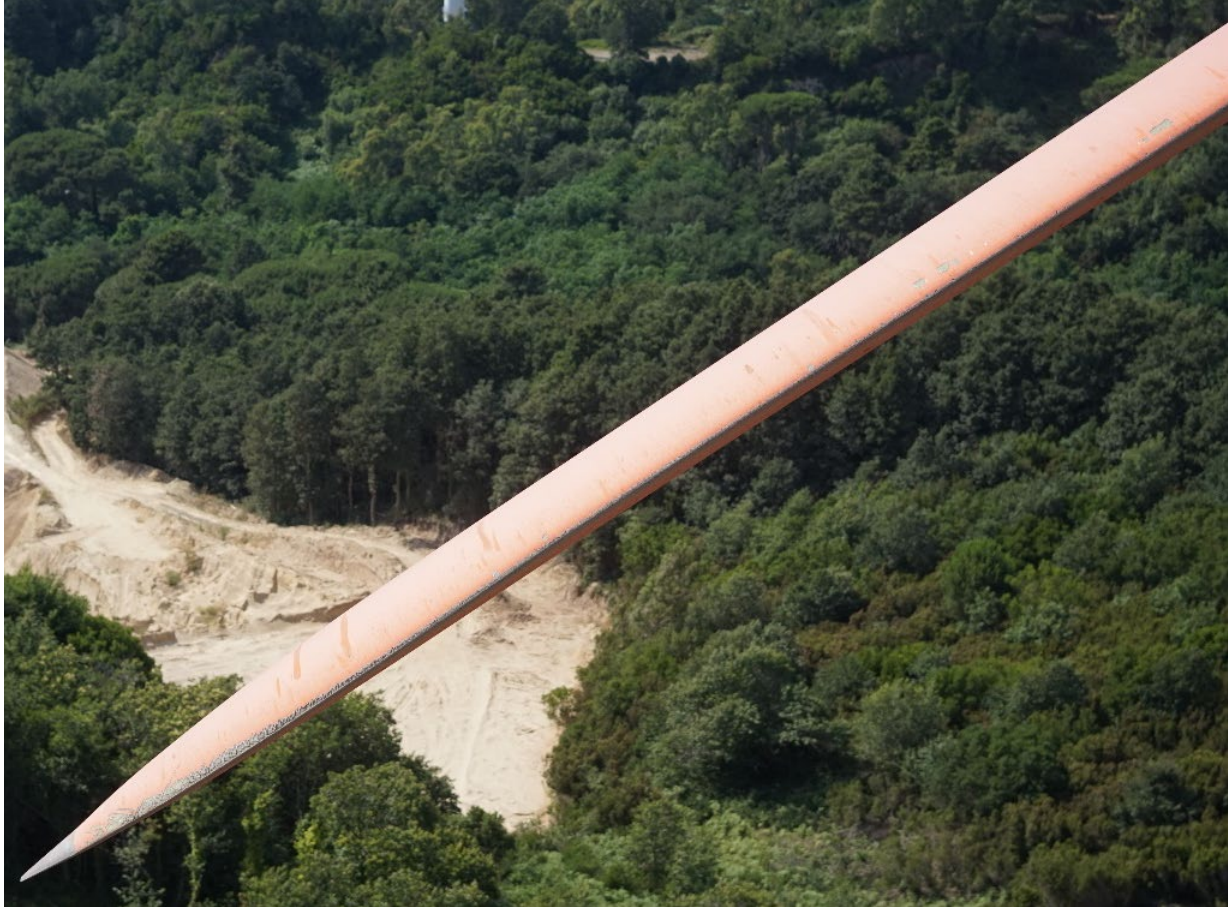
The blade in the above image appears to have category 4 erosion near the blade tip, as the fiberglass layers appear exposed and damaged. The erosion category moves to 3 further inboard and then to category 2. This is an example of classic erosion progression along the blade span. The blade could be categorized either by the maximum erosion category near the tip (4) or by the location of inboard progression using identification algorithms.

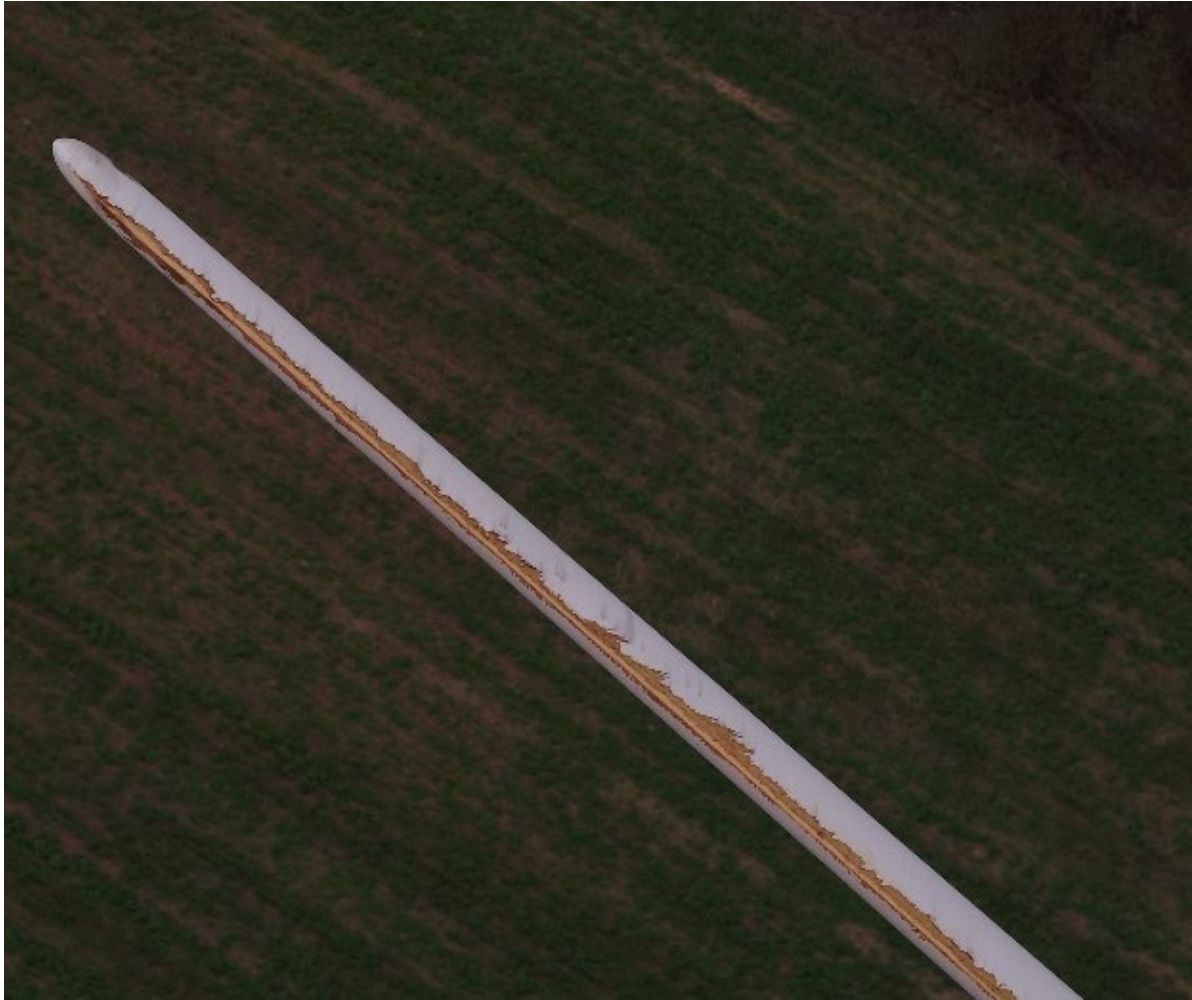
This blade appears to fall into category 4 erosion. The outer coating and layers are fully eroded at the leading edge. There is also evidence of some local peeling, which can cause even higher aerodynamic drag losses than erosion alone as the peeling can cause flow separation behind it.
