IEA Wind Task 46

Erosion of wind turbine blades

D4.2 Erosion failure modes in leading edge systems

Technical report

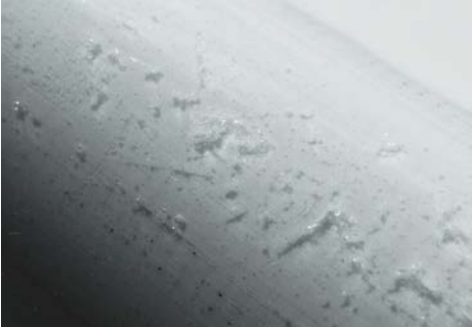
Description						Defect Appearance					
The defect type is characterized by morphology change with little to none material removal. Typically seen on homogeneous materials. It is usually the first defect appearing during a RET. As can be seen on the illustration, the rough/matt appearance occur because of crack formation in the n layer (LEP). These cracks results in reflected light being diffused giving rise to the matt appearance						The appearance is very dependent on the material, on metallic surfaces it is seen as a loss of gloss. On Clear coatings it can be seen as cracks normal to the surface as illustrated					
Affecting layers						This type of defect is similar to initial material removal. Can also look like point erosion.					
Coating specific layer name	LEP	Coating	Filler	Surface laminate	Laminate						
Layer number	n	n-1	n-2	0	-1	Approximate IEA erosion severity Level:					
Affecting layers	x

Figure 4: Damage images for pre-incubation.

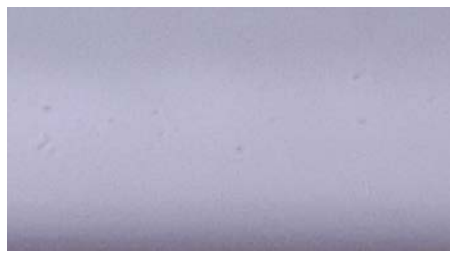
Description						Defect Appearance					
The defect is characterized by local material loss and is usually the starting point of erosion development. The damage is within a confined area without connecting to preexisting erosion, limited to the top coating within a single layer.						Defect size is equal to coating thickness squared or smaller. The damage is entirely confined to the outer n layer with no penetration					
						Interchangeable defects					
Affecting layers						<ul style="list-style-type: none"> Homogeneous roughening – distinct spots with clear difference from the neighboring area Local erosion – Limited to single layer 					
Example of coating specific layer name	LEP	Coating	Filler	Surface laminate	Laminate						
Layer number	n	n-1	n-2	0	-1	Approximate IEA erosion severity Level:					
Affecting layers	x					0: 29%	1: 14%	2: 14%	3	4:28%	5:14%
Example images											
Illustration		1				2

Figure 5: Damage images for end of incubation.

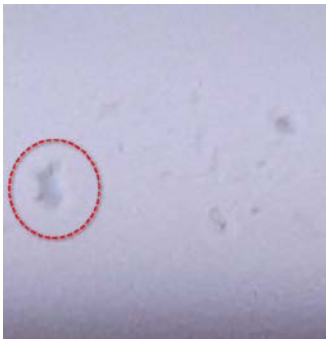
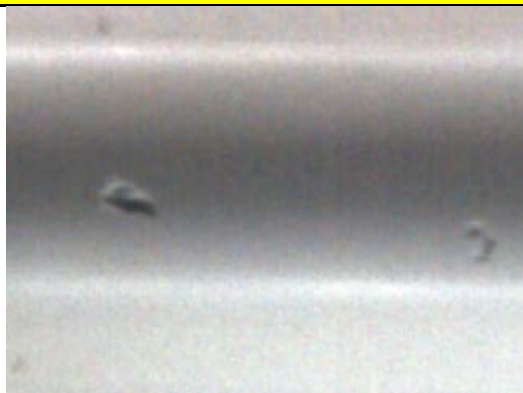
Description						Defect Appearance					
<p>The defect is characterized by local material loss exposing an underlying layer. This is usually the starting point of erosion development. The damage is within a confined area without connecting to preexisting erosion. Within this area, the defect can propagate to the underlying area.</p>						<p>Defect size is equal to coating thickness squared or larger. The damage has removed part of the n layer exposing the n-1 layer. Typically, underlying layers have different colors to the top coating. This makes this type of damage, relatively easy to identify. And</p>					
Affecting layers						<ul style="list-style-type: none"> • Initial material removal • Homogeneous roughening 					
Example of coating specific layer name	LEP	Coating	Filler	Surface laminate	Laminate						
Layer number	n	n-1	n-2	0	-1						
Affecting layers	x	x	(x)			0:	1:29%	2:14%	3:14%	4:29%	5: 14%

Figure 6: Damage images for incubation, point erosion.

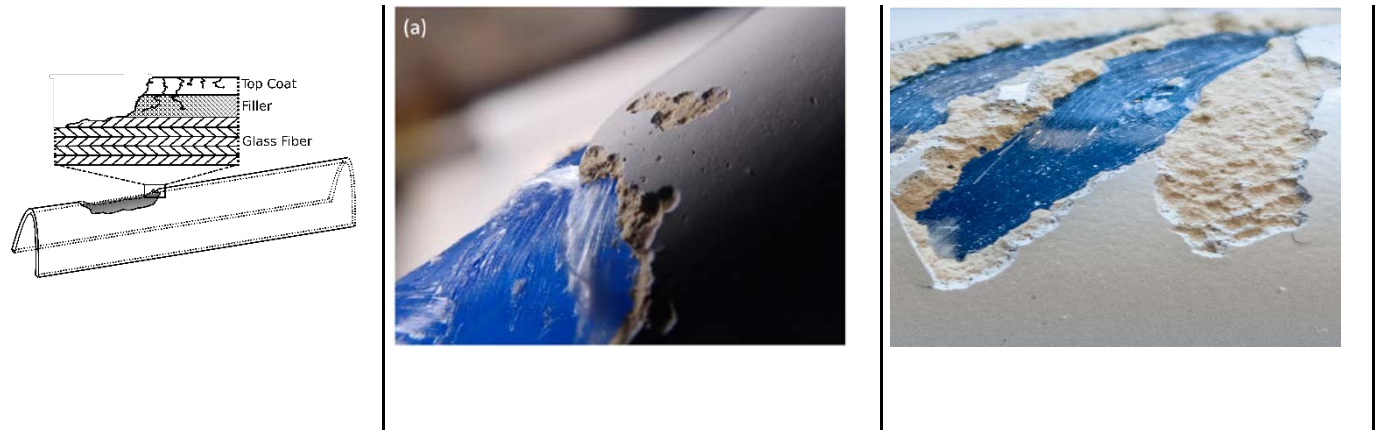
Description						Defect Appearance					
<p>The defect is defined by exposed substrate as a result of complete coating and filler material failure.</p> <p>The main characteristic of the defect type is that exposed laminate areas can be discreet. This failure indicates a good adhesion between the substrate and the coating layer(s).</p>						<ul style="list-style-type: none"> Discreet areas of failure On laminate substrates the damage follows the top layer fibre direction. Commonly 45 degree stripes are observed on fiberglass samples, due to the biax top layers 					
						Interchangeable defects					
Affecting layers						<ul style="list-style-type: none"> Adhesive failure – damage to the substrate is visible in the case of cohesive failure 					
Example of coating specific layer name	LEP	Coating	Filler	Surface laminate	Laminate						
Layer number	n	n-1	n-2	0	-1	Approximate IEA erosion severity Level:

Figure 8: Breakthrough to substrate – cohesive failure.

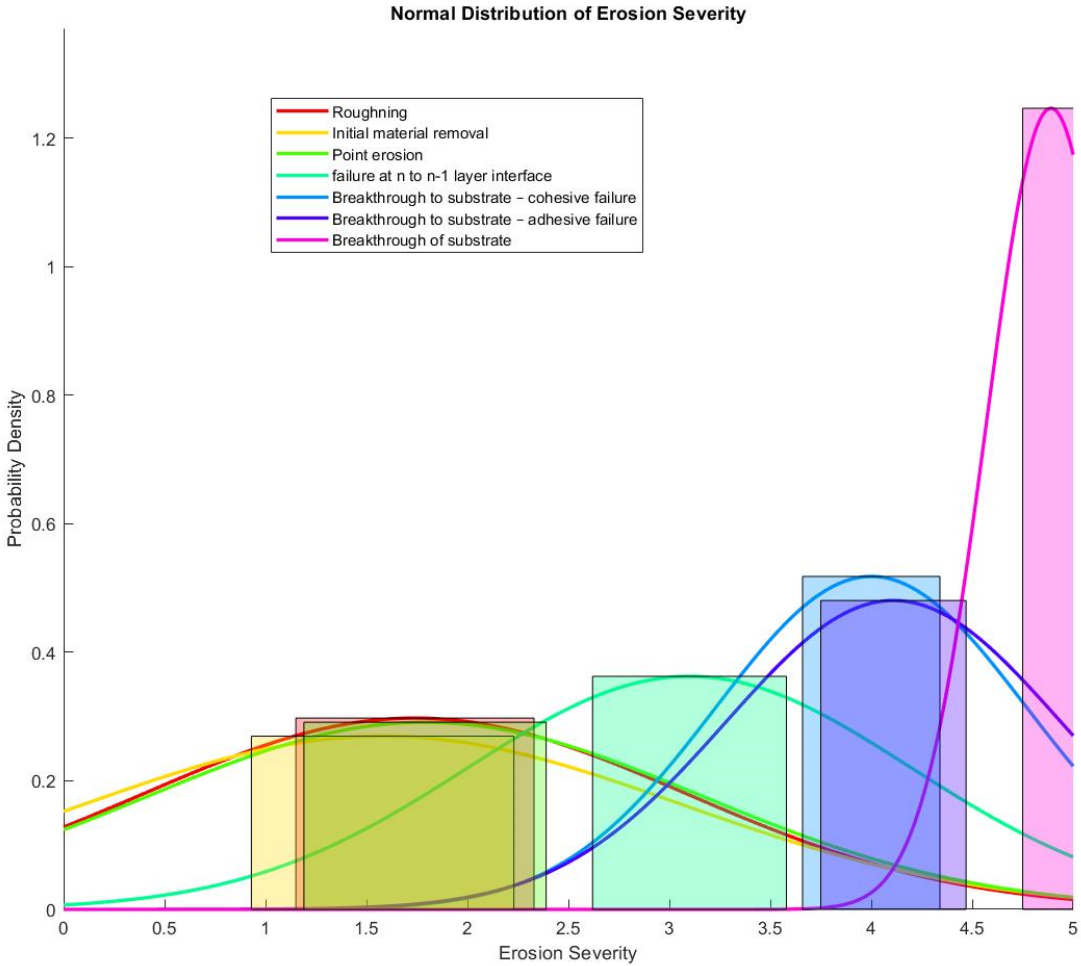
Figure 11: Summary of results from questionnaire.

Analysing responses to the questionnaire, roughning, initial material removal and point erosion get assigned a similar IEA erosion class. This might indicate that they should all be classified as incubation type damages. Figure 11 shows three incubation classes to overlay. The breakthrough to substrate whether cohesive or adhesive failure overlap. Failure at n to n-1 layer is distinct. Also breakthrough to substrate is distinct according to the results from the questionnaire.
