Erosion of wind turbine blades

**Pre-evaluation of test
specimen**

Technical report

**Prepared for the
International Energy Agency Wind Implementing Agreement**

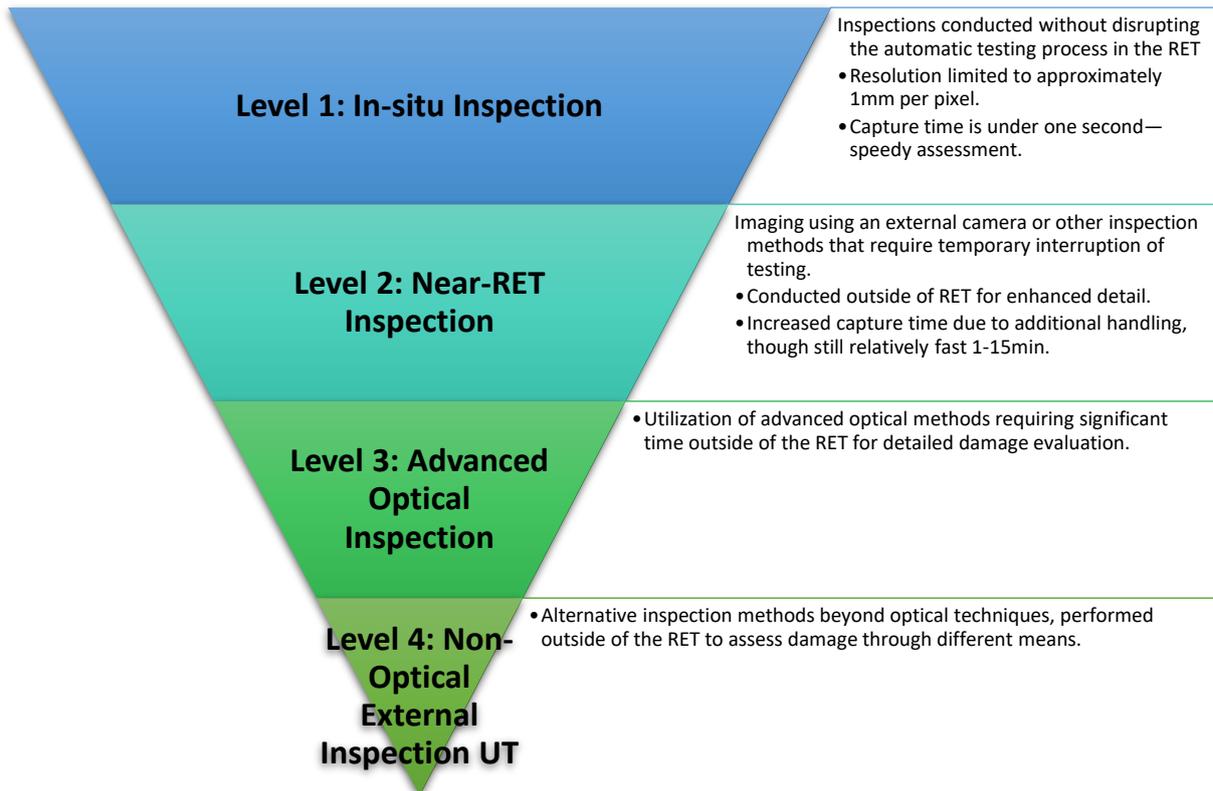
Figure 1. Different levels of inspection for rain erosion test specimen.

- **Level 1: In-situ Inspection** - Inspections conducted without disrupting the automatic testing process in the RET.
- **Level 2: Near-RET Inspection** - Imaging using an external camera or other inspection methods that require temporary interruption of testing.
- **Level 3: Advanced Optical Inspection** - Utilization of advanced optical methods requiring significant time outside of the RET for detailed damage evaluation.
- **Level 4: Non-Optical External Inspection UT** - Alternative inspection methods beyond optical techniques, performed outside of the RET to assess damage through different means.

The structure for the report will focus on different levels of inspection that can be employed for RET specimens shown in Figure 1.

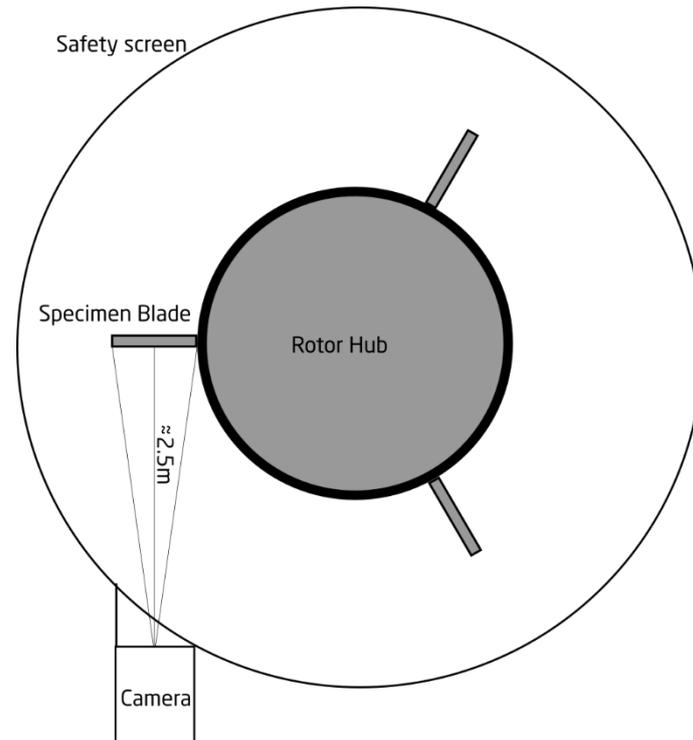
Figure 2 Illustration to approximate scale of the average R&D A/S RET, with camera position shown and approximate distance from camera to specimen at imaging position.

As a result of the RET imaging system, the sample will always be moving during image capture at an angular velocity of **0.5 rad/s**, with a **closing velocity of 0.6 m/s** at the blade tip. Therefore, the camera's shutter time must be short to minimize motion blur and ensure clear image acquisition. Figure 2 shows the geometry.

During imaging, each blade is illuminated along its length, and a picture is captured when the blade is positioned normal to the camera's line of sight. This method ensures consistent imaging conditions while maintaining an automated testing process. The camera is placed approximately 2.5 meters away from the sample and zoomed in to cover the visible span of 430 mm.

This would result in a deviation of approximately **17°**, meaning perspective distortion would be much more pronounced. Objects closer to the camera would appear disproportionately larger than those farther away, making it harder to achieve accurate and consistent measurements.

Thus, placing the camera farther from the sample reduces these distortions and improves the reliability of imaging for erosion analysis. However, for applications requiring even greater accuracy, a **telecentric lens** would be necessary to eliminate perspective effects entirely.

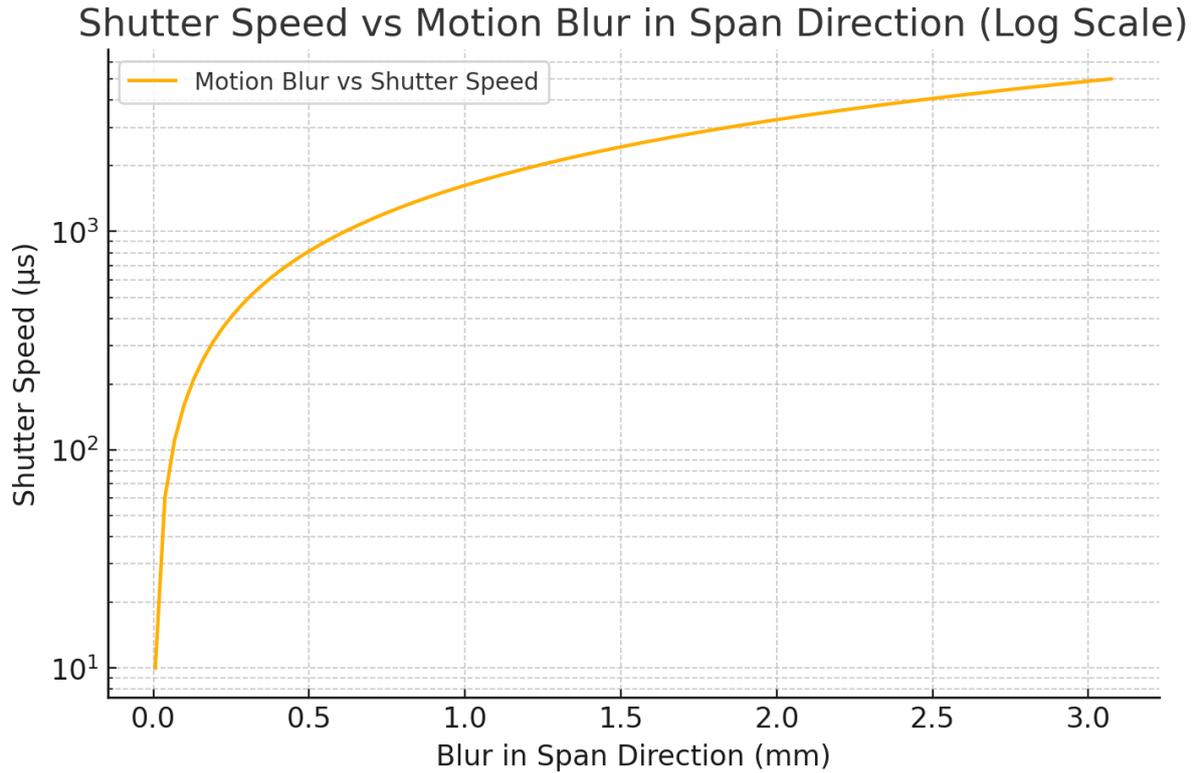
To estimate the worst-case blur, we consider a point at the **tip of the blade**, where motion in the spanwise direction is most pronounced as the blade moves toward the camera. This relationship between shutter speed and motion blur is visualized in **Figure 3**.

Since we are looking for **incubation damage of approximately 1 mm in size** [3], we apply a general rule of thumb: motion blur should be less than **50% of the feature size** to ensure clear detection. From the plot, we can determine that to keep the blur below **0.5 mm**, the shutter speed must be **less than 900 μ s**.

Figure 3 Relationship Between Shutter Speed and Motion Blur.

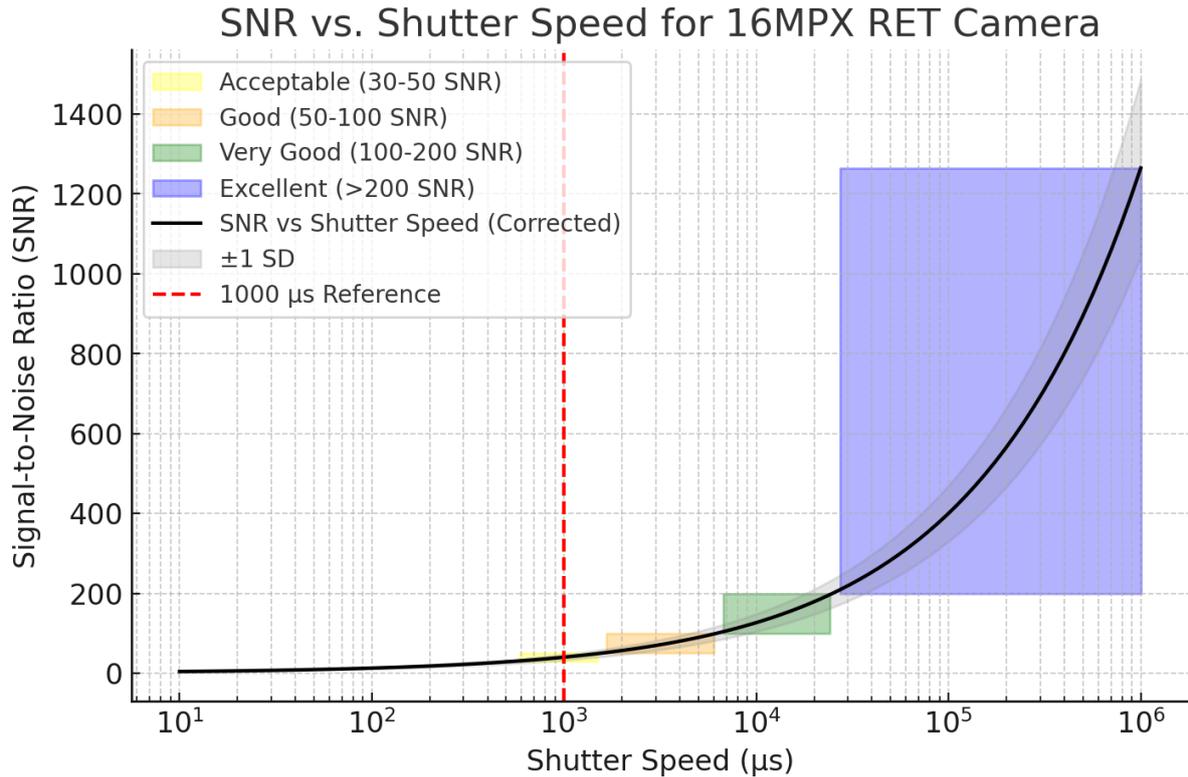
The relationship between SNR and shutter speed can be calculated, as shown in Figure 4. The measured SNR of 40 at 1000 µs serves as a reference to estimate the possible SNR at different shutter speeds.

From the plot, we see that the RET imaging system falls just within the acceptable range. However, this also highlights the limitations of the current state-of-the-art RET imaging system, particularly in applications requiring higher precision and lower noise.

Figure 4 SNR vs. shutter speed for the 16MPX RET camera, showing how signal-to-noise ratio decreases as exposure time is reduced. The shaded regions indicate different quality levels for analytical work, with a red dashed line at 1000 µs marking the reference SNR of 40.

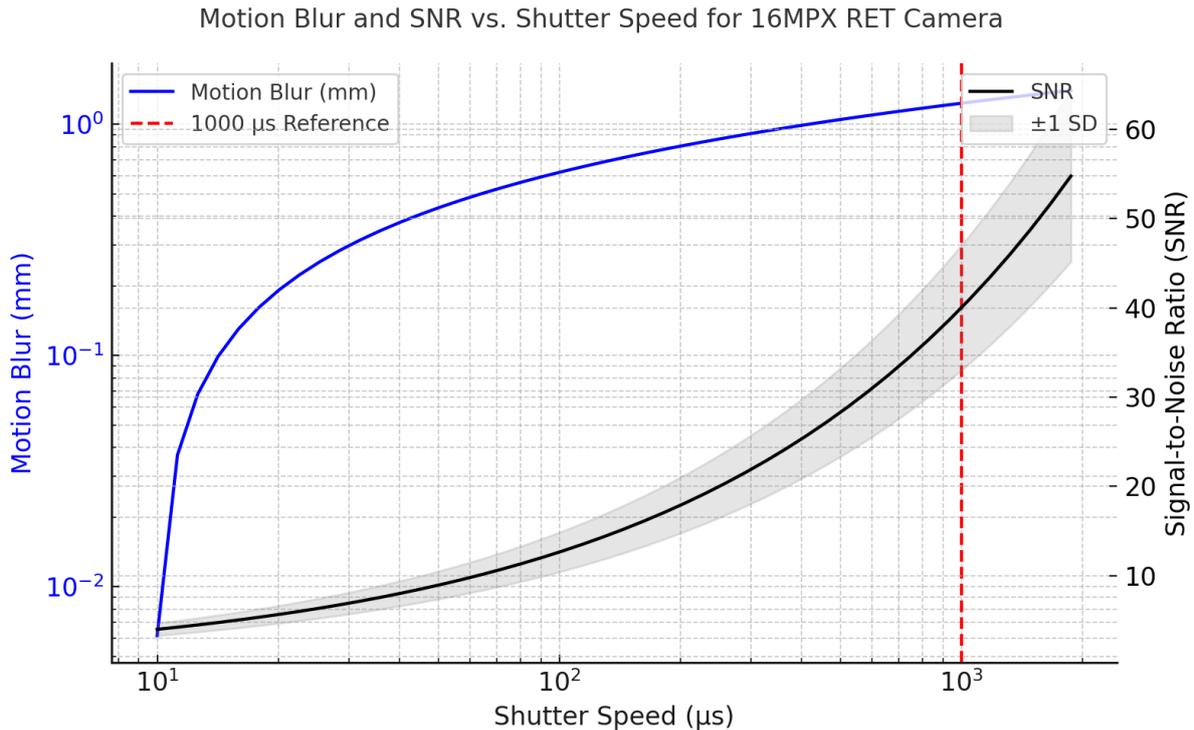
So we can combine the two plots to see the consequences on image quality, as shown in Figure 5. This visualization highlights the trade-offs between motion blur and signal-to-noise ratio (SNR) as a function of shutter speed.

From the data, it is evident that at very short shutter speeds, blur becomes negligible, but noise increases significantly. On the other hand, longer shutter speeds improve SNR but introduce motion blur, which can obscure fine details. The reference point at 1000 microseconds, where an SNR of 40 was measured, falls within an acceptable range for analytical work but highlights the limitations of the current imaging system in capturing both sharp and low-noise images simultaneously.

Figure 5 Motion Blur and SNR vs. Shutter Speed for the 16MPX RET Camera.

This trade-off is crucial when selecting optimal imaging settings for rain erosion testing, where both fine detail resolution and sufficient signal quality are necessary for accurate defect detection and incubation analysis.

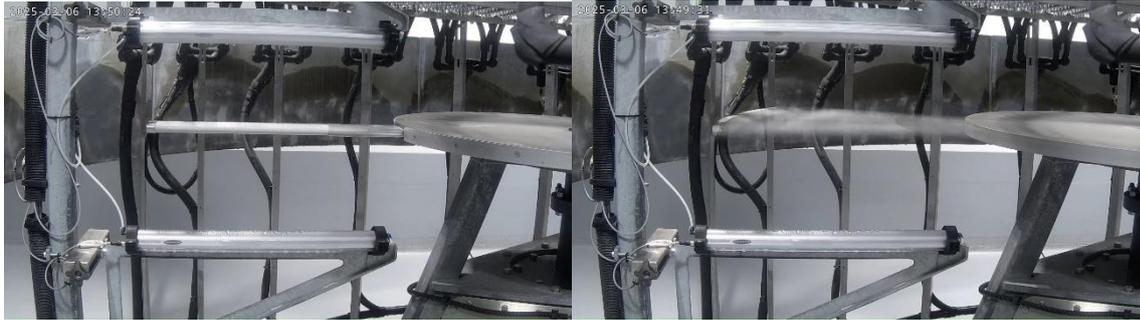
With by placing a video camera in a similar position to the inline cameras we illustrate the effect of the blur on sharpness

Figure 6. The left is shown a still from video taken while RET is at capture speed 5rpm. To the right is shown the same blade at testing speed 160m/s.

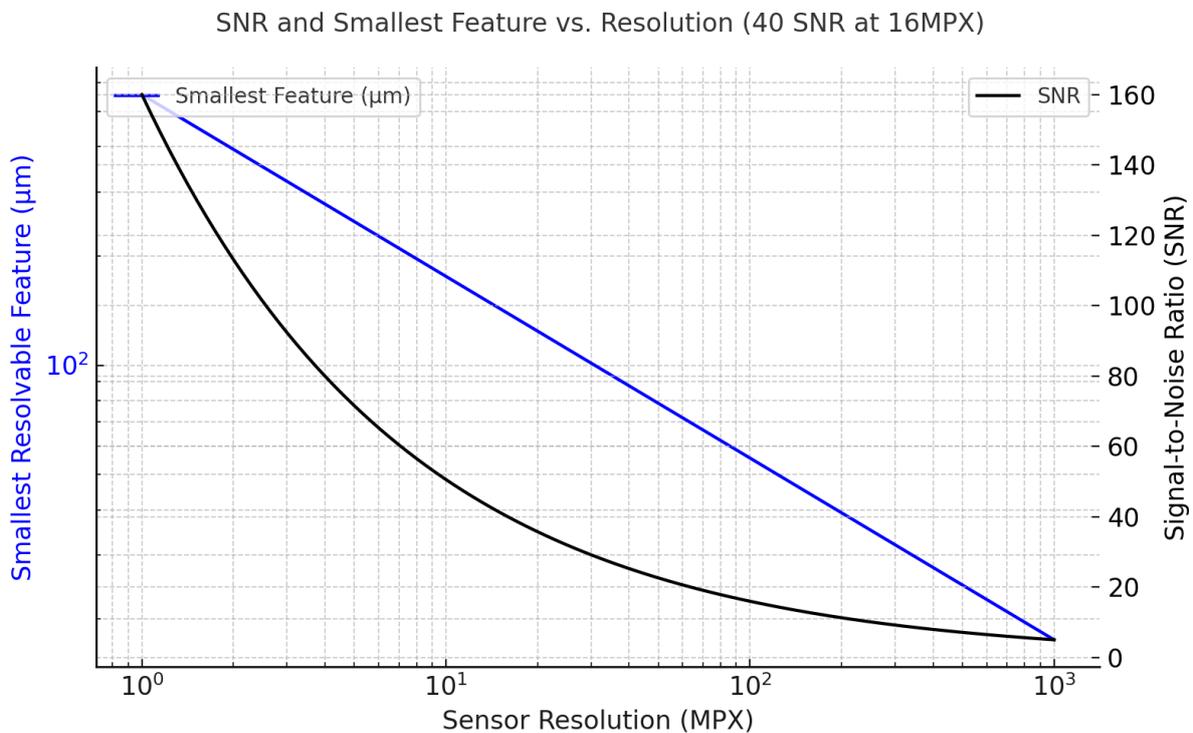
If the illumination of the samples is not increased accordingly, Figure 7 shows that further resolution gains may not significantly improve image quality due to the limitations imposed by SNR. In such cases, the system reaches a point where additional pixels do not provide better detail but instead amplify noise, making it necessary to adjust other imaging parameters to fully utilize the benefits of higher-resolution sensors.

Figure 7 Effect of Increasing Sensor Resolution on SNR.

However, as sensor resolution increases while all other factors remain the same, the signal-to-noise ratio (SNR) decreases, as shown in Figure 6. This happens because higher resolution sensors have smaller individual pixels, leading to less light collected per pixel. Since the total light captured by the sensor remains constant, the per-pixel signal decreases, while the noise, primarily photon shot noise and read noise, does not scale down proportionally.

This means that while higher resolutions allow for smaller feature detection, they also introduce more noise, which can reduce the effective gain in detail resolution. If the pixel size becomes too small, the signal may become dominated by noise, making it difficult to distinguish fine incubation features from random fluctuations in brightness.

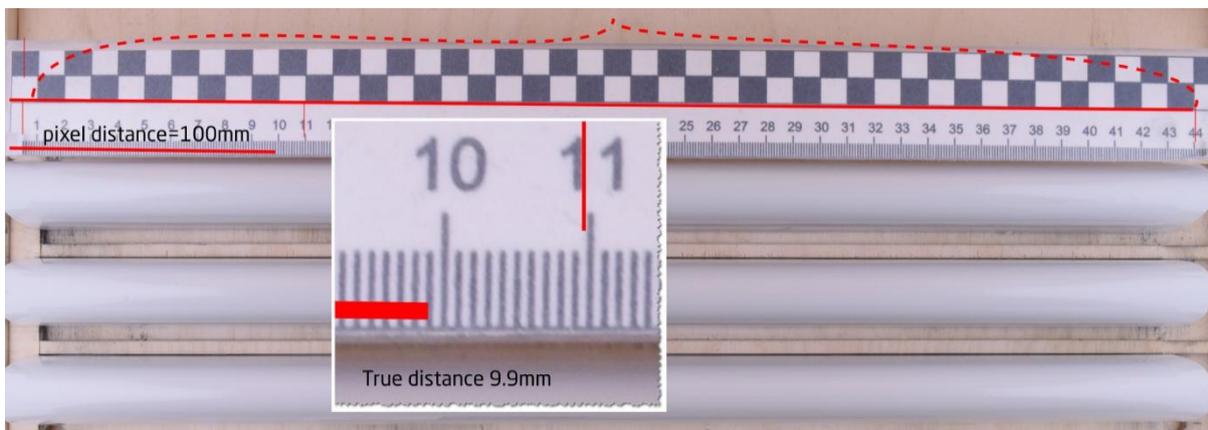
An example of this type of image can be seen in Figure 8. Here, the exposure is optimized. However, one challenge with this approach is the increased perspective distortion due to the short distance between the camera and the sample. If not corrected, this distortion can lead to measurement inaccuracies

Typically, we use a two-point calibration based on the longest distance in the image, which in this case is 440 mm. When measuring from one side, a small but noticeable cumulative error in radial position arises between the edge of the sample and the optical center. This is evident in the image, where based on pixel distance calibration, we assume a measurement of 100 mm, but when checked against a scale, the actual measurement is only 99 mm. While small, this systematic error affects velocity measurements on the sample.

Figure 8 Example images of a RET samples photographed outside of the RET.

In principle, this error can be corrected using a geometric transformation, but in practice, it is rarely done. As a guideline for sample imaging outdoors, it is recommended to maximize the distance between the camera and the sample to minimize perspective distortion.

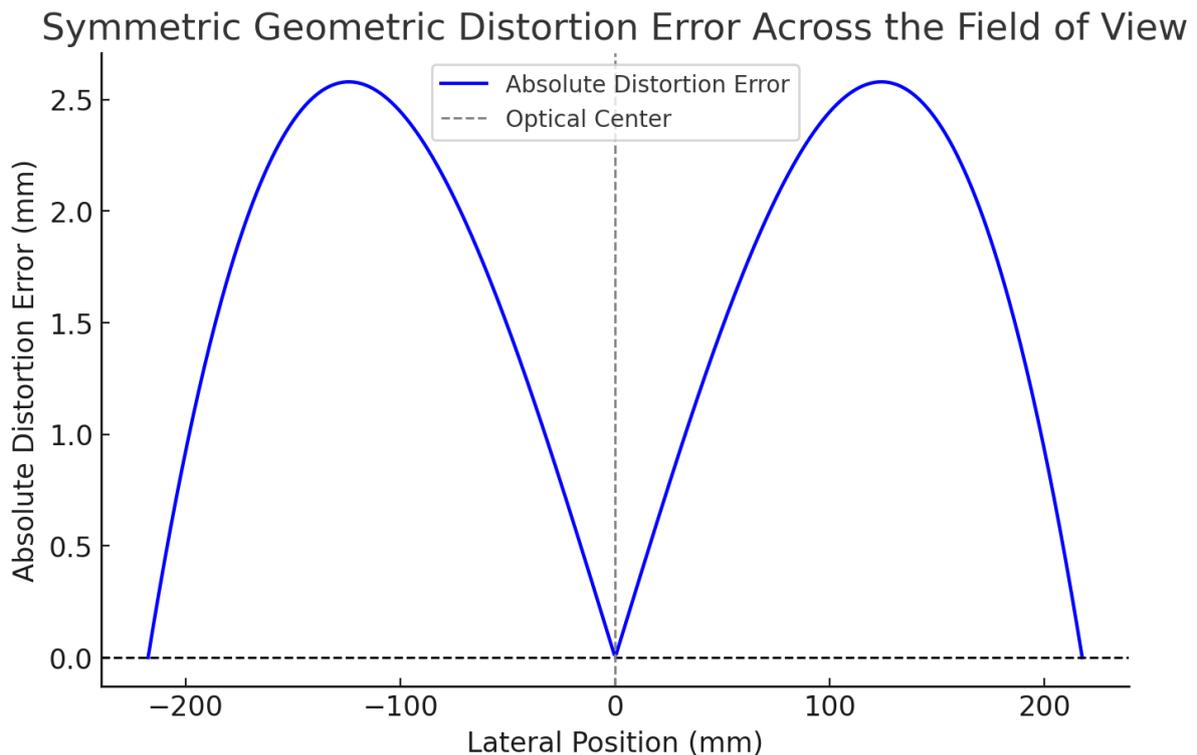
As a worst-case example of the distortion that can occur on a **435 mm-wide sample positioned 700 mm away** from the camera, we observe a distinct distortion profile, as shown in **Figure 9**. In this scenario, perspective effects cause a cumulative positional error, where points further from the optical center appear shifted due to the nonlinear mapping of real-world distances onto the image plane. The distortion is minimal at the **center** and **edges** of the field of view but peaks at intermediate positions, forming a characteristic **M-shaped error profile**. This effect can lead to small but systematic measurement inaccuracies, particularly when relying on direct pixel-based distance calibrations without correction for perspective distortion.

Figure 9 M-shaped absolute error in measured distance relative to the optical center, with known positions at both ends of the sample.

1. Perspective Distortion: a. While minimized due to the camera's placement, residual perspective distortion can lead to small but systematic measurement errors, particularly in radial position calibration. This is especially relevant for fine incubation damage detection.

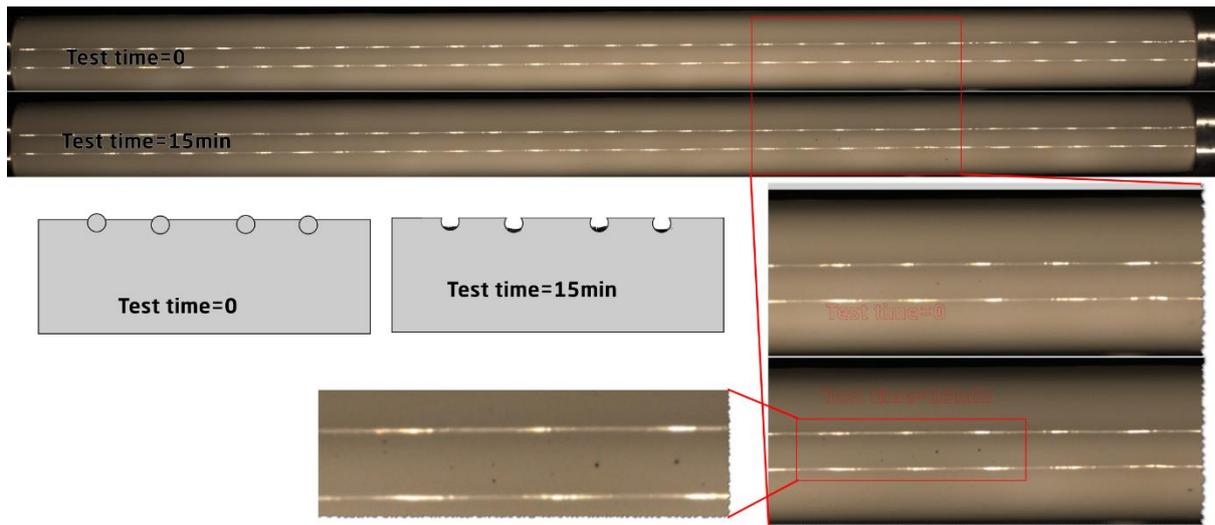
Several types of pre-existing defects can still be observed despite the limitations of the RET imaging system. Among them, pinholes are the most common, as illustrated in Figure 10. These defects typically form when small pre-existing bubbles in the coating become capped off during early inspections. Over time, these areas appear as dark spots, likely due to small amounts of eroded material collecting in the pits and absorbing light, enhancing their contrast in the image.

Figure 10 shows how pinholes get exposed early on in the erosion process.

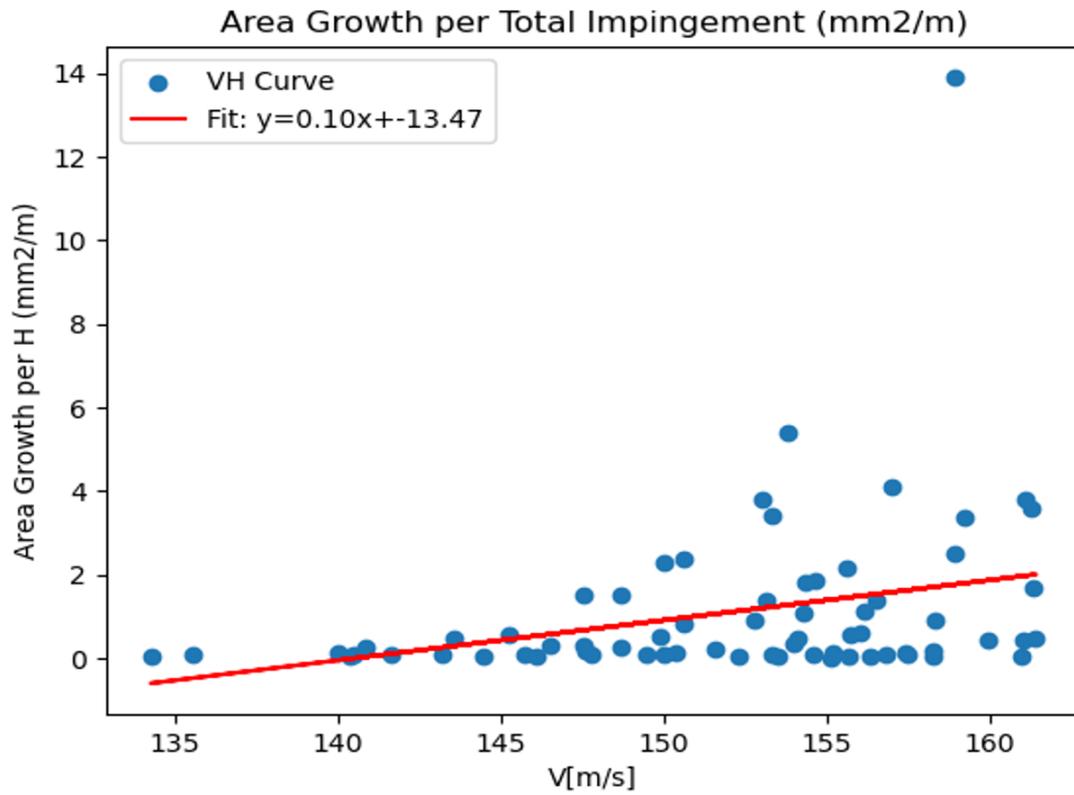
This effect is reflected in the area growth rate of damages on blades with pinholes, where many damages are distributed across a wide velocity range, as shown in Figure 11. However, we also observe that while some damages show little to no evolution in area as a function of impingement, others grow rapidly. A possible hypothesis is that at high speeds, a pinhole can act as an initiating or accelerating factor, leading to early damage once the material surpasses its damage threshold, as observed by Evans [3].

Figure 11 Shows the area growth rate as measured using DTU-RETINA annotation tool.

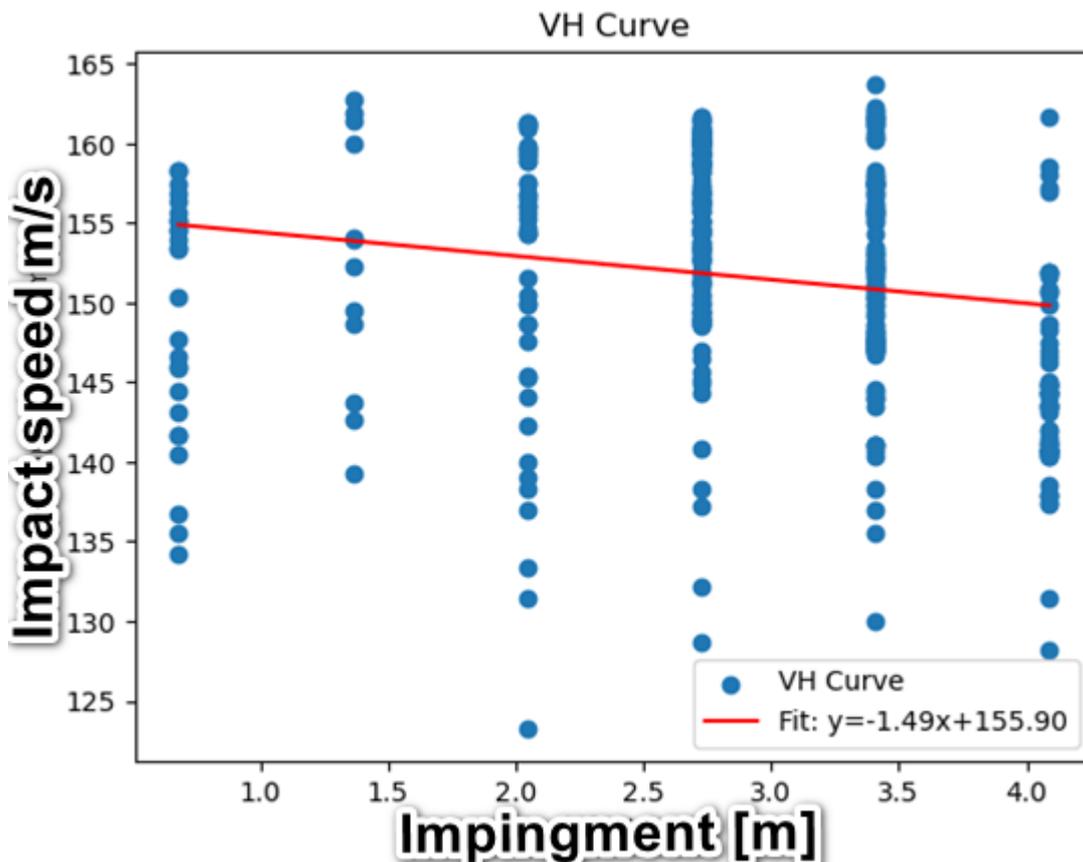
This provides additional insight into materials and tests where the presence of pre-existing defects can significantly impact the validity of VN curves. The appearance of pinholes does not truly represent the incubation phase, as there is no significant loss of coating immediately after their first visual detection. As a result, the VN curves can become unreliable, as illustrated in Figure 12.

Figure 12 Shows the VH curve for a material presenting with many pinholes.

3. Defect Misclassification: a. Pre-existing defects such as pinholes can be detected in the inline RET system, but their impact on incubation and erosion progression is difficult to quantify. b. Pinholes may create misleading incubation curves, where damage appears early but without true material loss. This can lead to inaccurate VN curves, requiring additional validation.

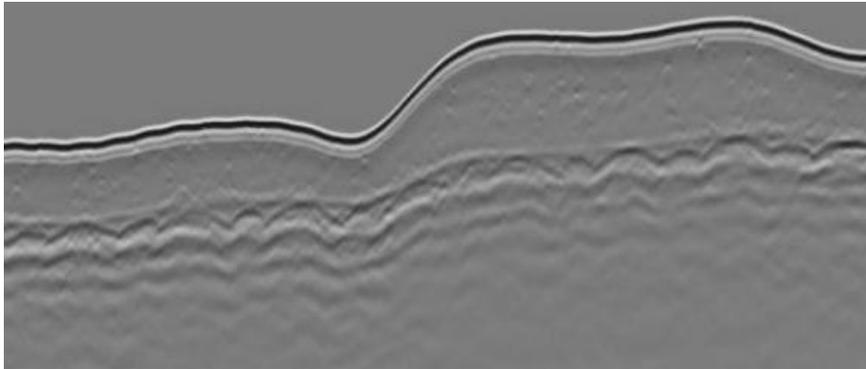
This is important as the minimum resolvable size that something with a differing acoustic impedance can be detected is approximately 0.5 times the wavelength of the selected inspection frequency (as illustrated in Figure 14). However, surface topology and sample thicknesses can be determined directly, to inspect irregularities or areas of reduced coating thickness (As illustrated in Figure 13).

Figure 13: Surface topology of a coated composite sample using a scanning acoustic microscope. The black line in the image represents the surface of the coating, with the wavy surfaces below showing the composite layers. Defects within the coating barely are visible in this image.

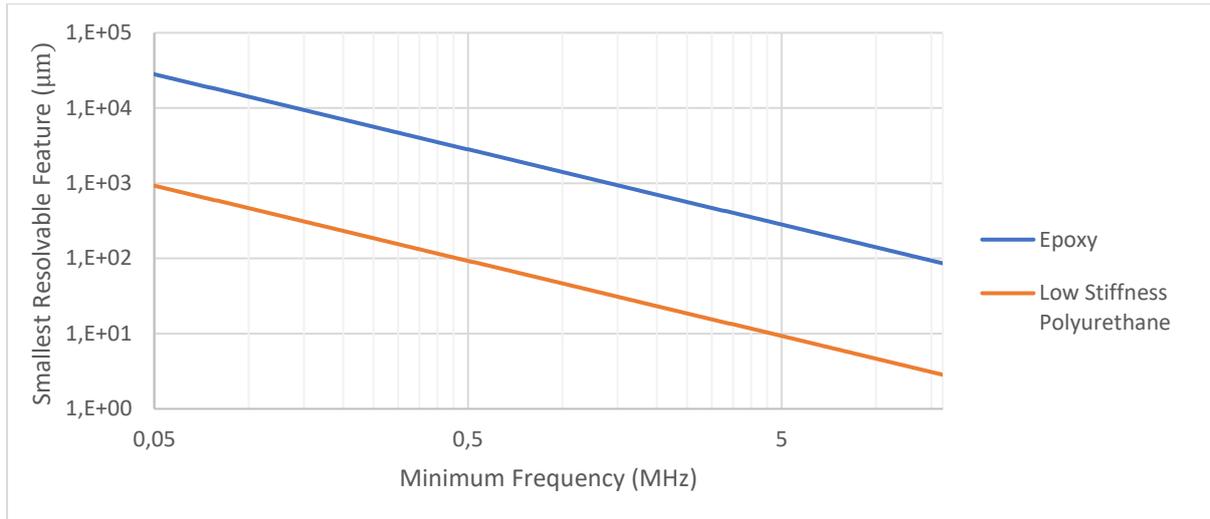
Figure 14: Minimum resolvable size feature for a low stiffness polyurethane vs an epoxy.

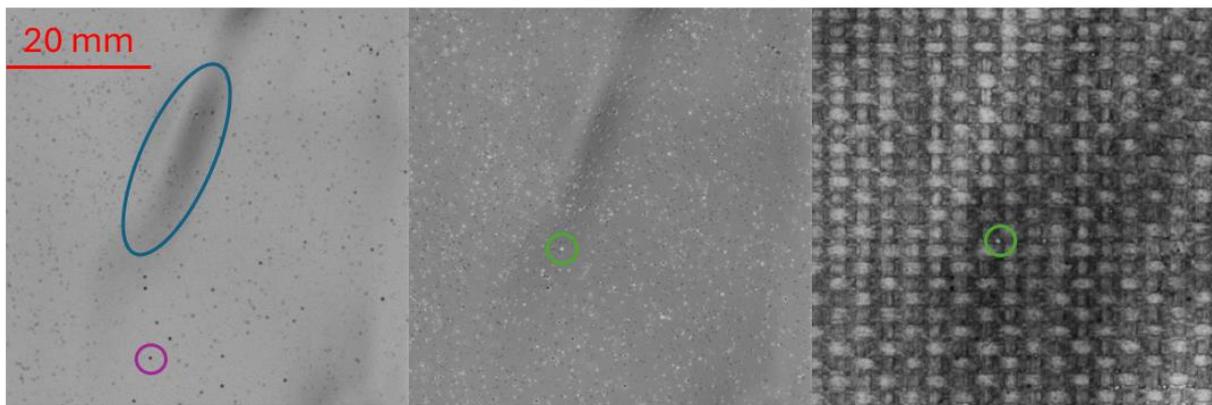
The combined effect of acoustic impedance mismatch, defect geometry and internal sample geometry determine the signal strength received for a given defect. For air bubbles, voids or delamination, there is a significant acoustic impedance difference, making detection easier than, for example, the interface between two similar polymers. So, in practice this means that extracting features between two objects with similar material properties may be complicated to do whilst also ensuring that feature can be extracted from the signal noise. This also presents challenges when trying to detect smaller voids in composites that are comparable to the fibre size in composites (As illustrated in Figure 15). However, it is possible to investigate that coatings that protect composites and the interfaces between these coatings and composites.

Figure 15: Example ultrasound inspection of a coating surface, subsurface and coating-composite interface. Voids are visible (circled in green), pinholes are visible in purple and surface waviness are visible in blue.
